## **Indicator Stalk Removal and Self-Cancelling Fix.**

### ***Removing the Indicator Stalk console.***

***Fixing the self-cancelling mechanism***

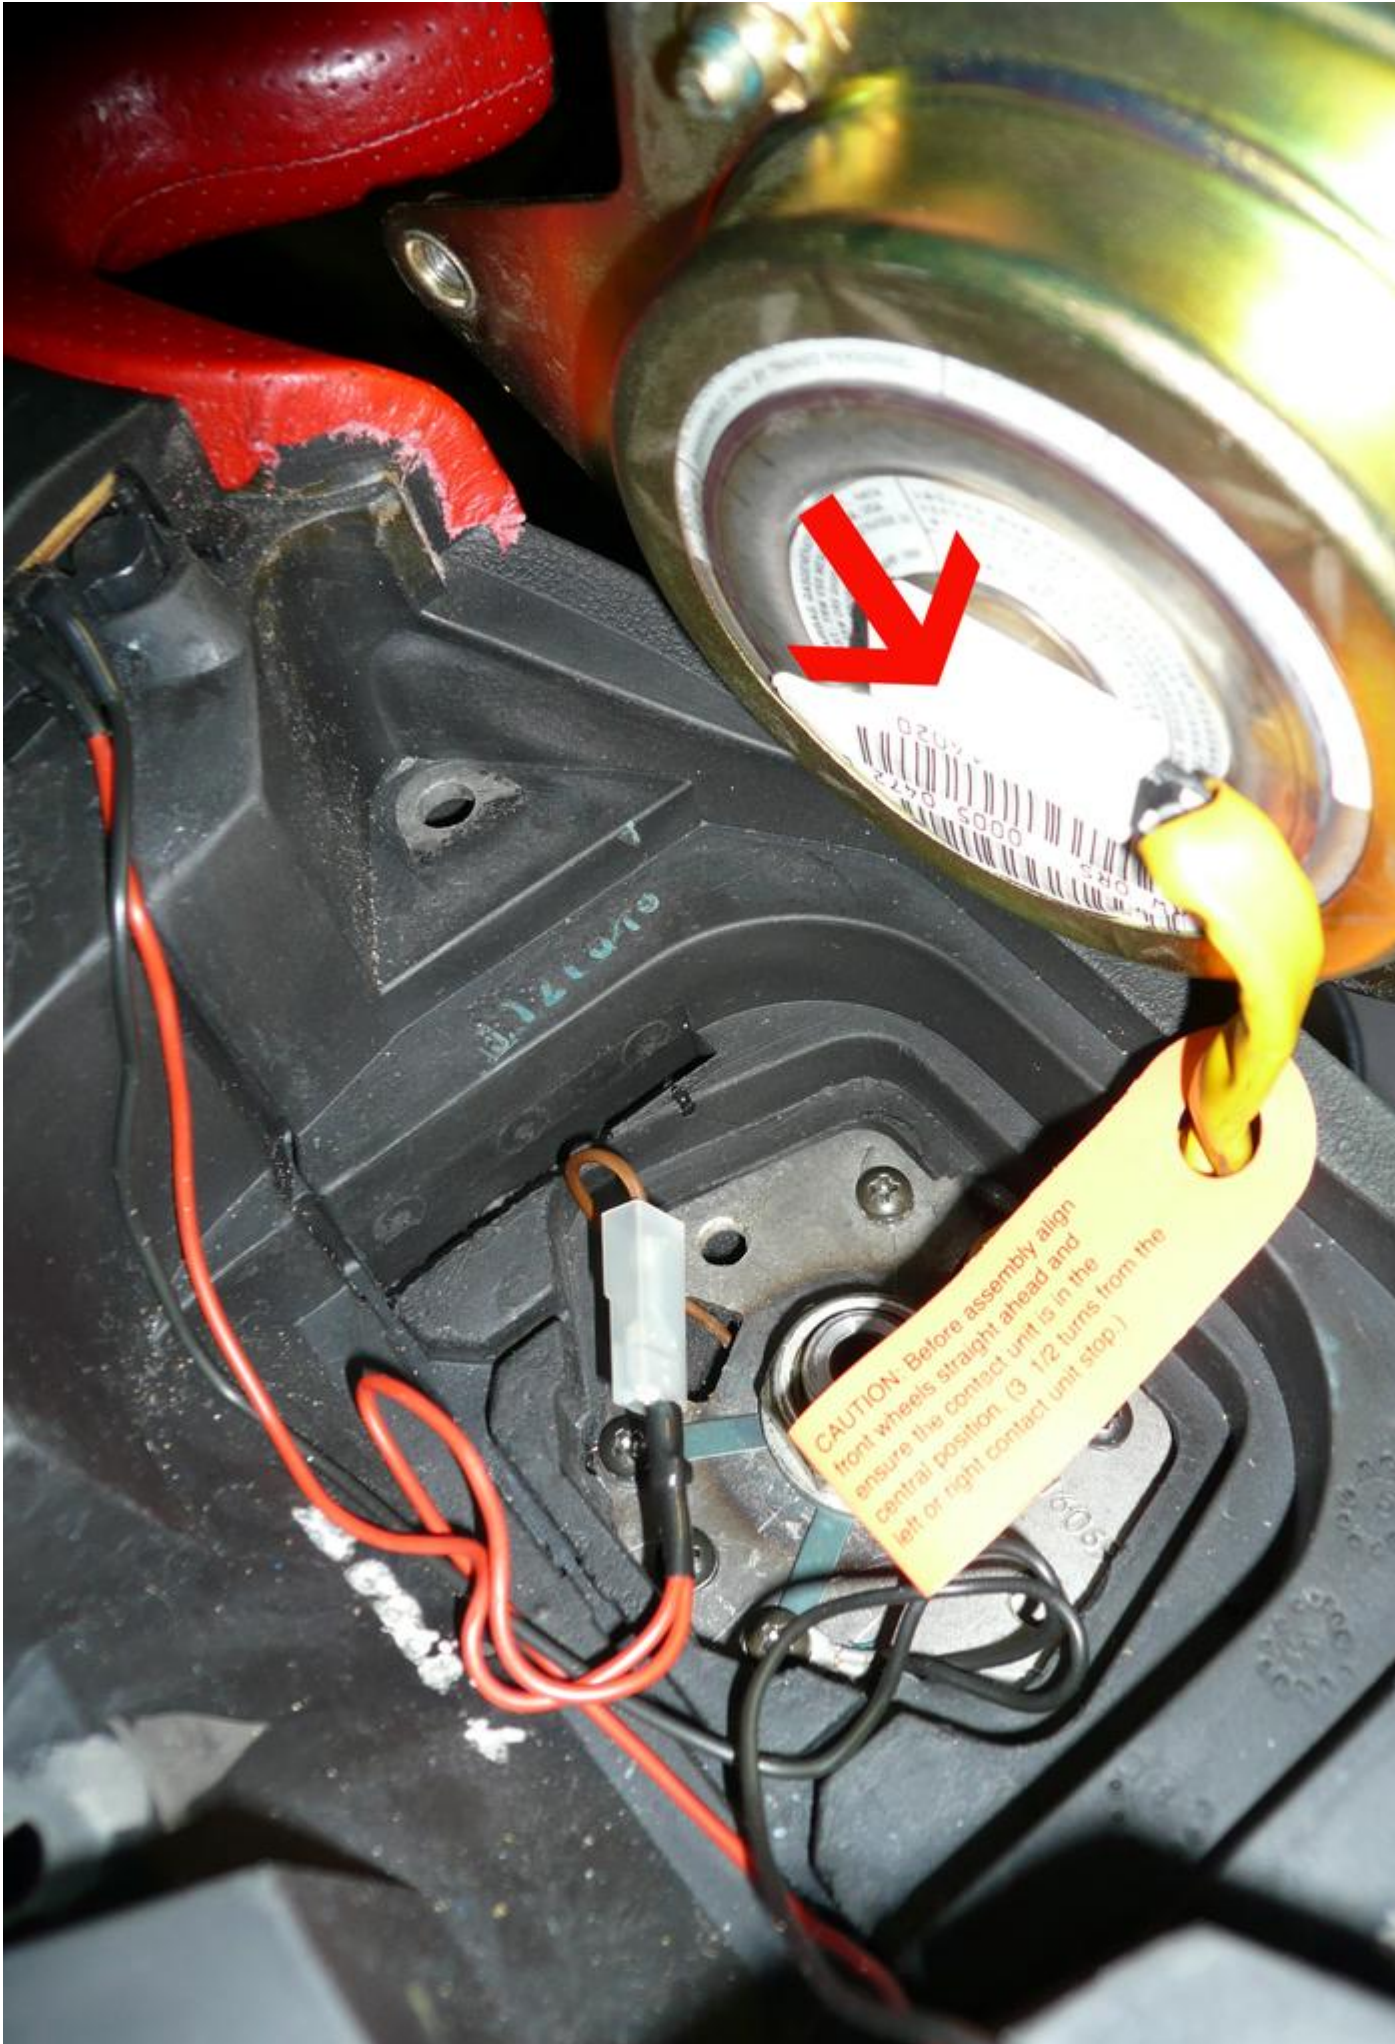
Once unscrewed, gently lift up the airbag. You will see that it is connected to a yellow cable.

Carefully unplug the cable off the airbag. Put aside the disconnected airbag face-up at a safe place.

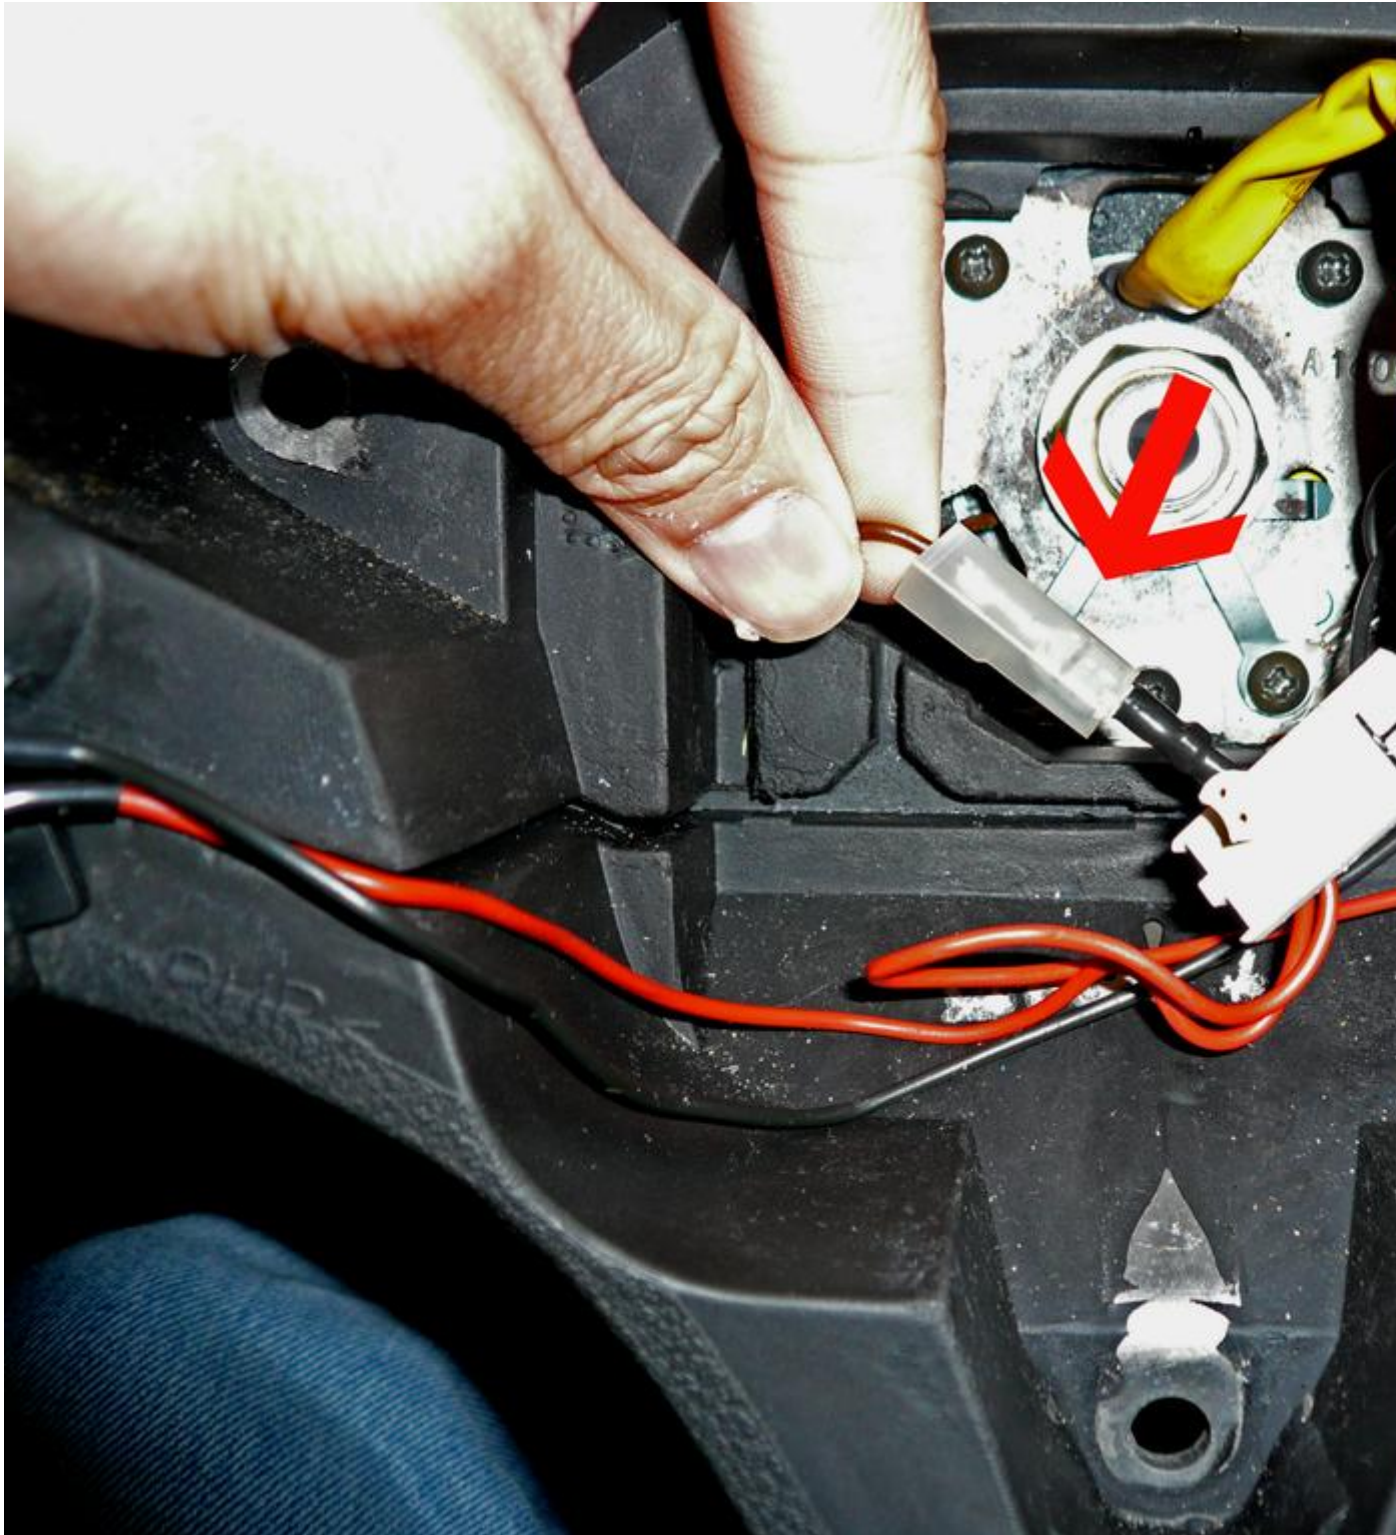
Next, disconnect the horn wiring. It is the brown wire that is connected to the red wire via spade connectors.

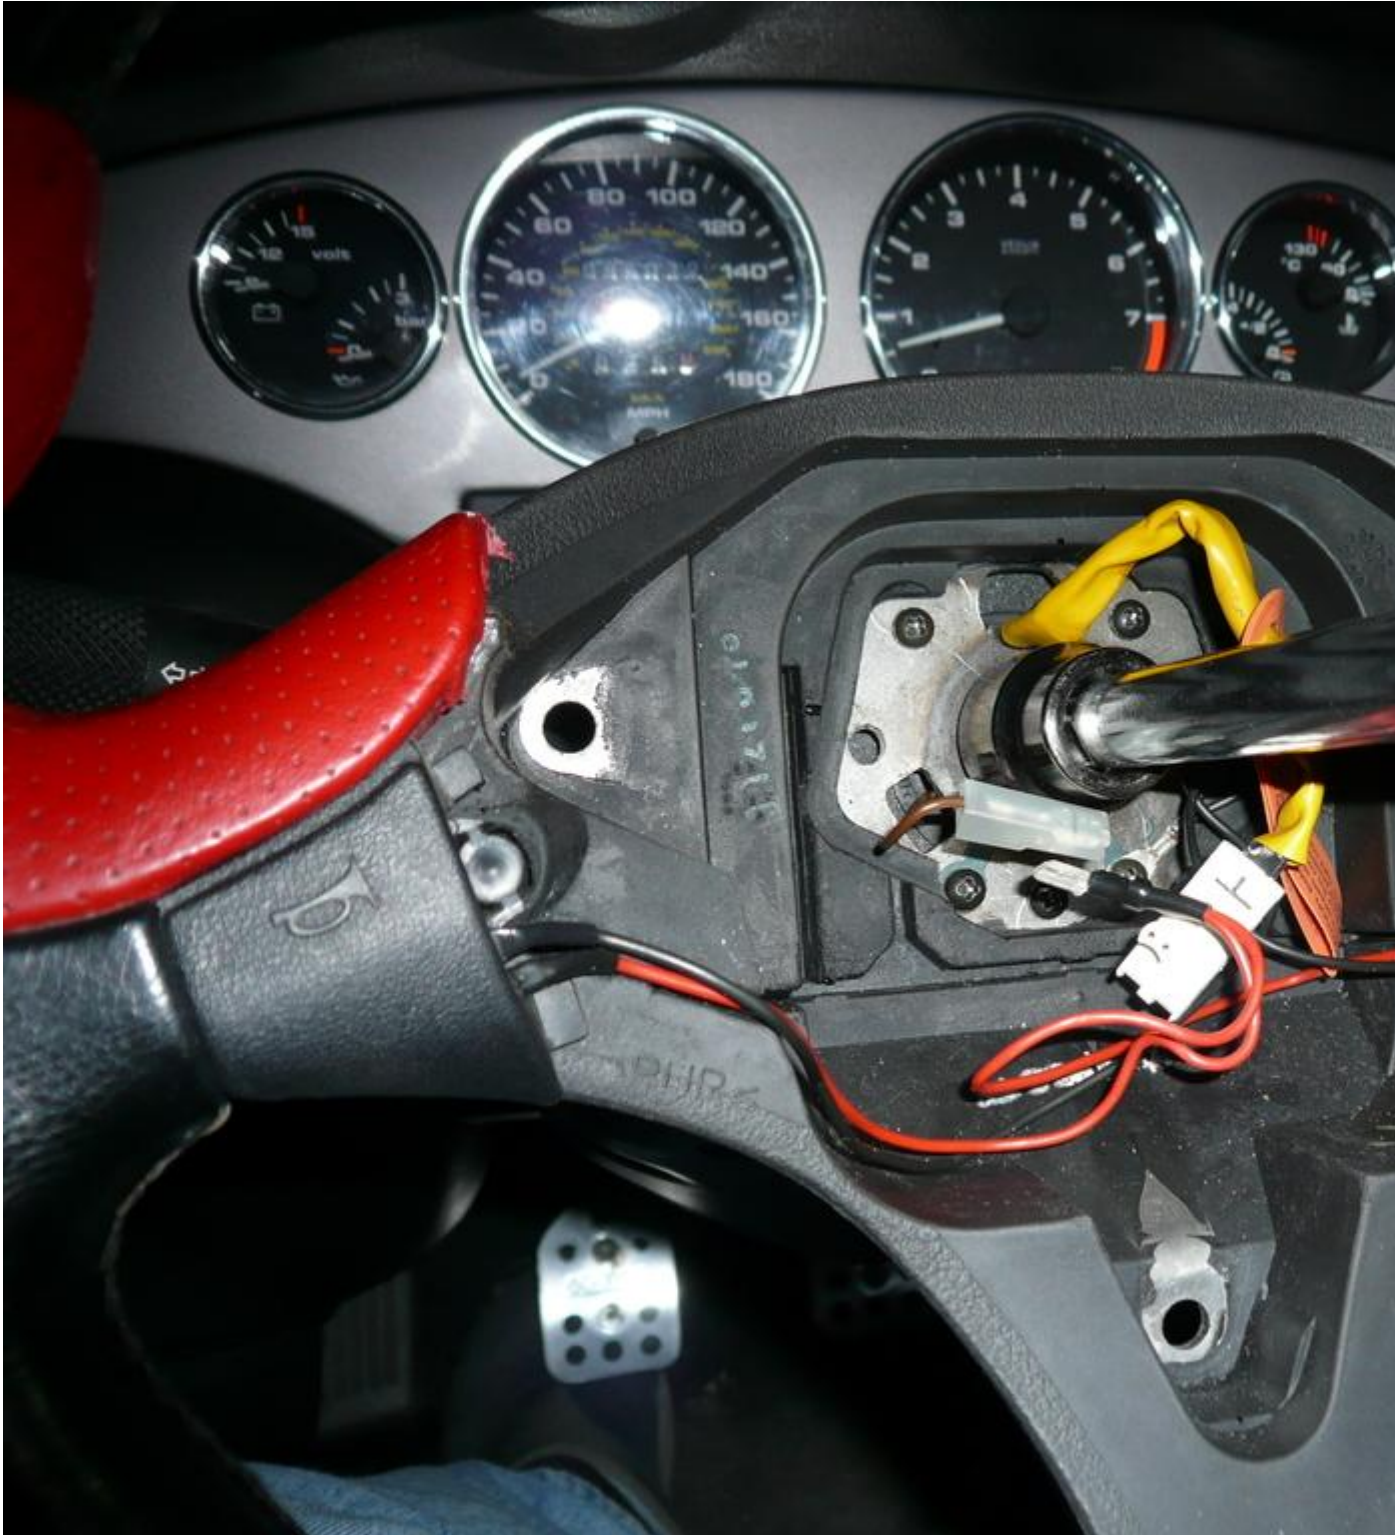
With the wires disconnected, you can now loosen the big nut that secures the steering wheel using a 24mm socket. You might need an extension bar with your socket in order for the ratchet to clear the steering wheel. Loosen the nut enough to give slack to the wheel but leave the nut on.

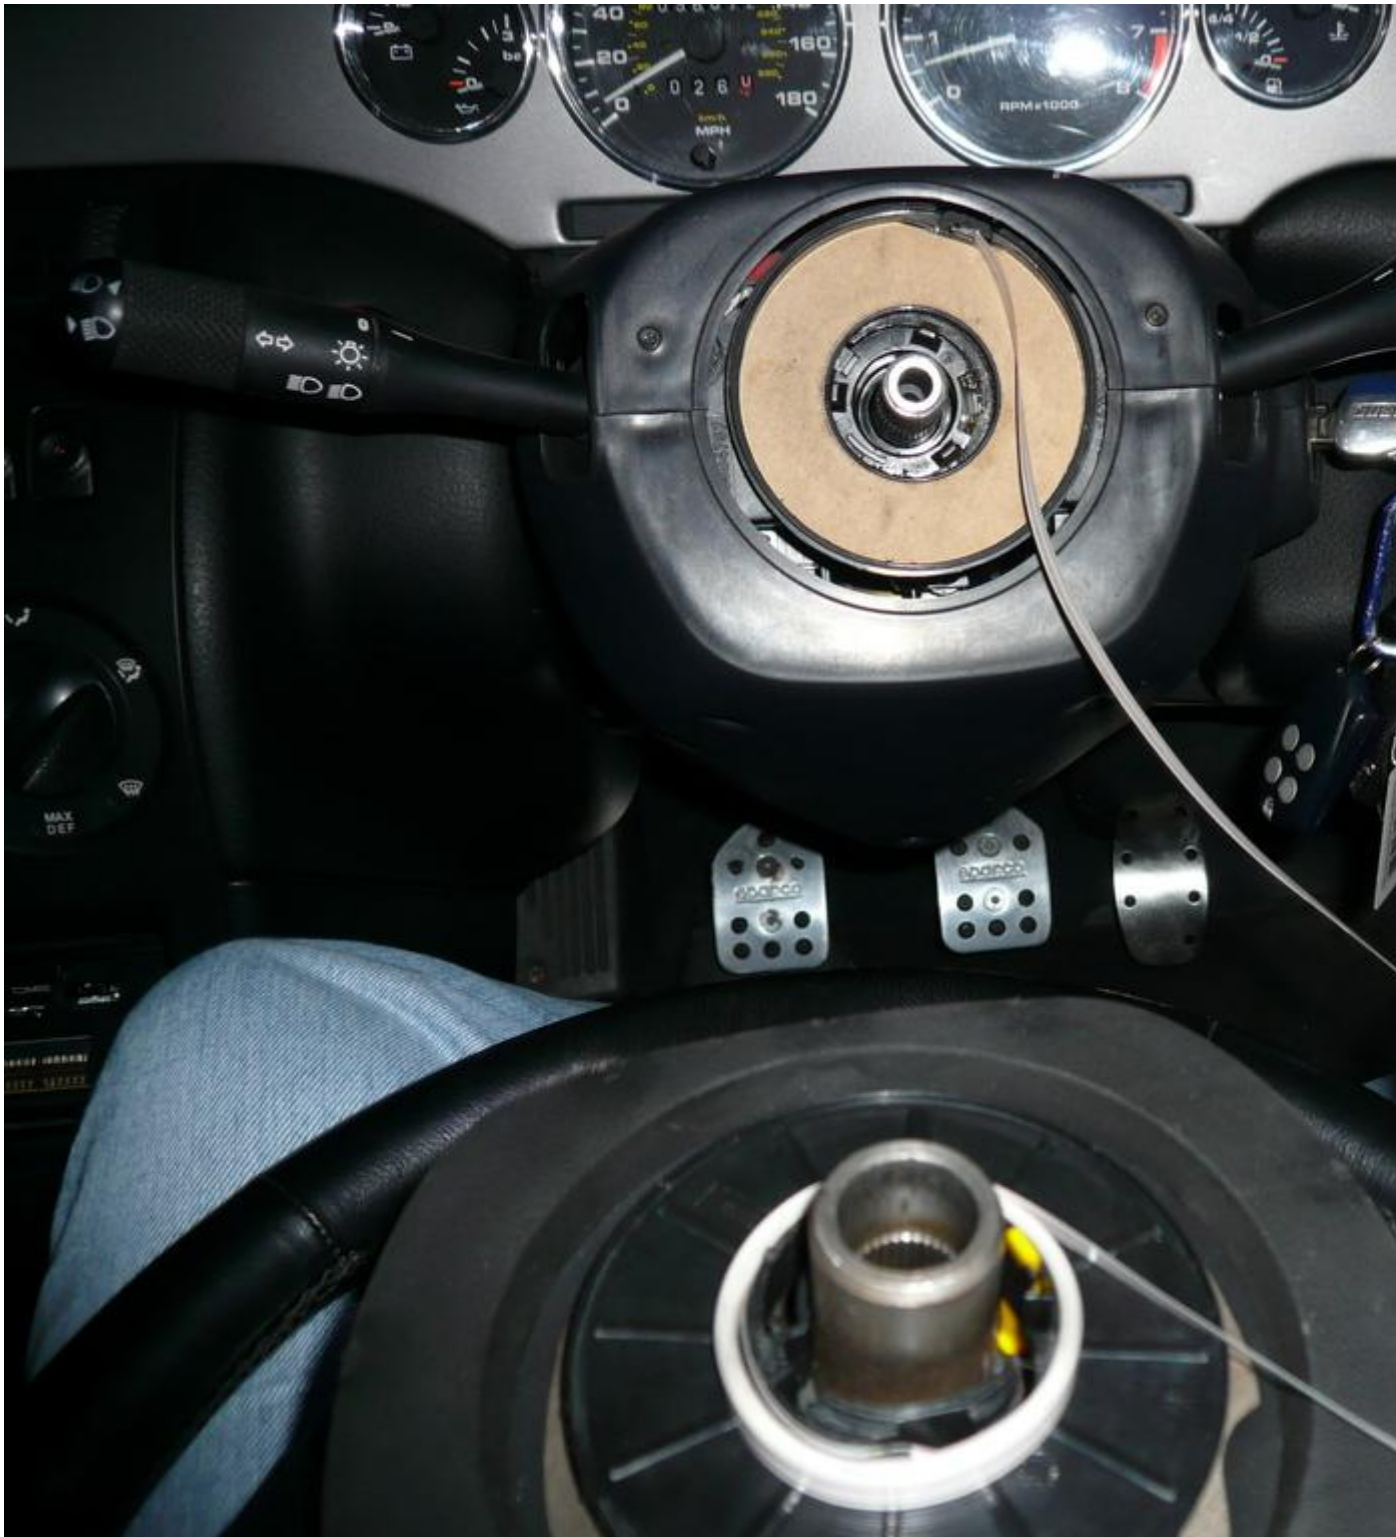
If you don't remove the 3 screws, you're going to pop open the clock-spring casing when you remove the steering wheel and get the roll of flex tape strewn everywhere like this. Very messy!

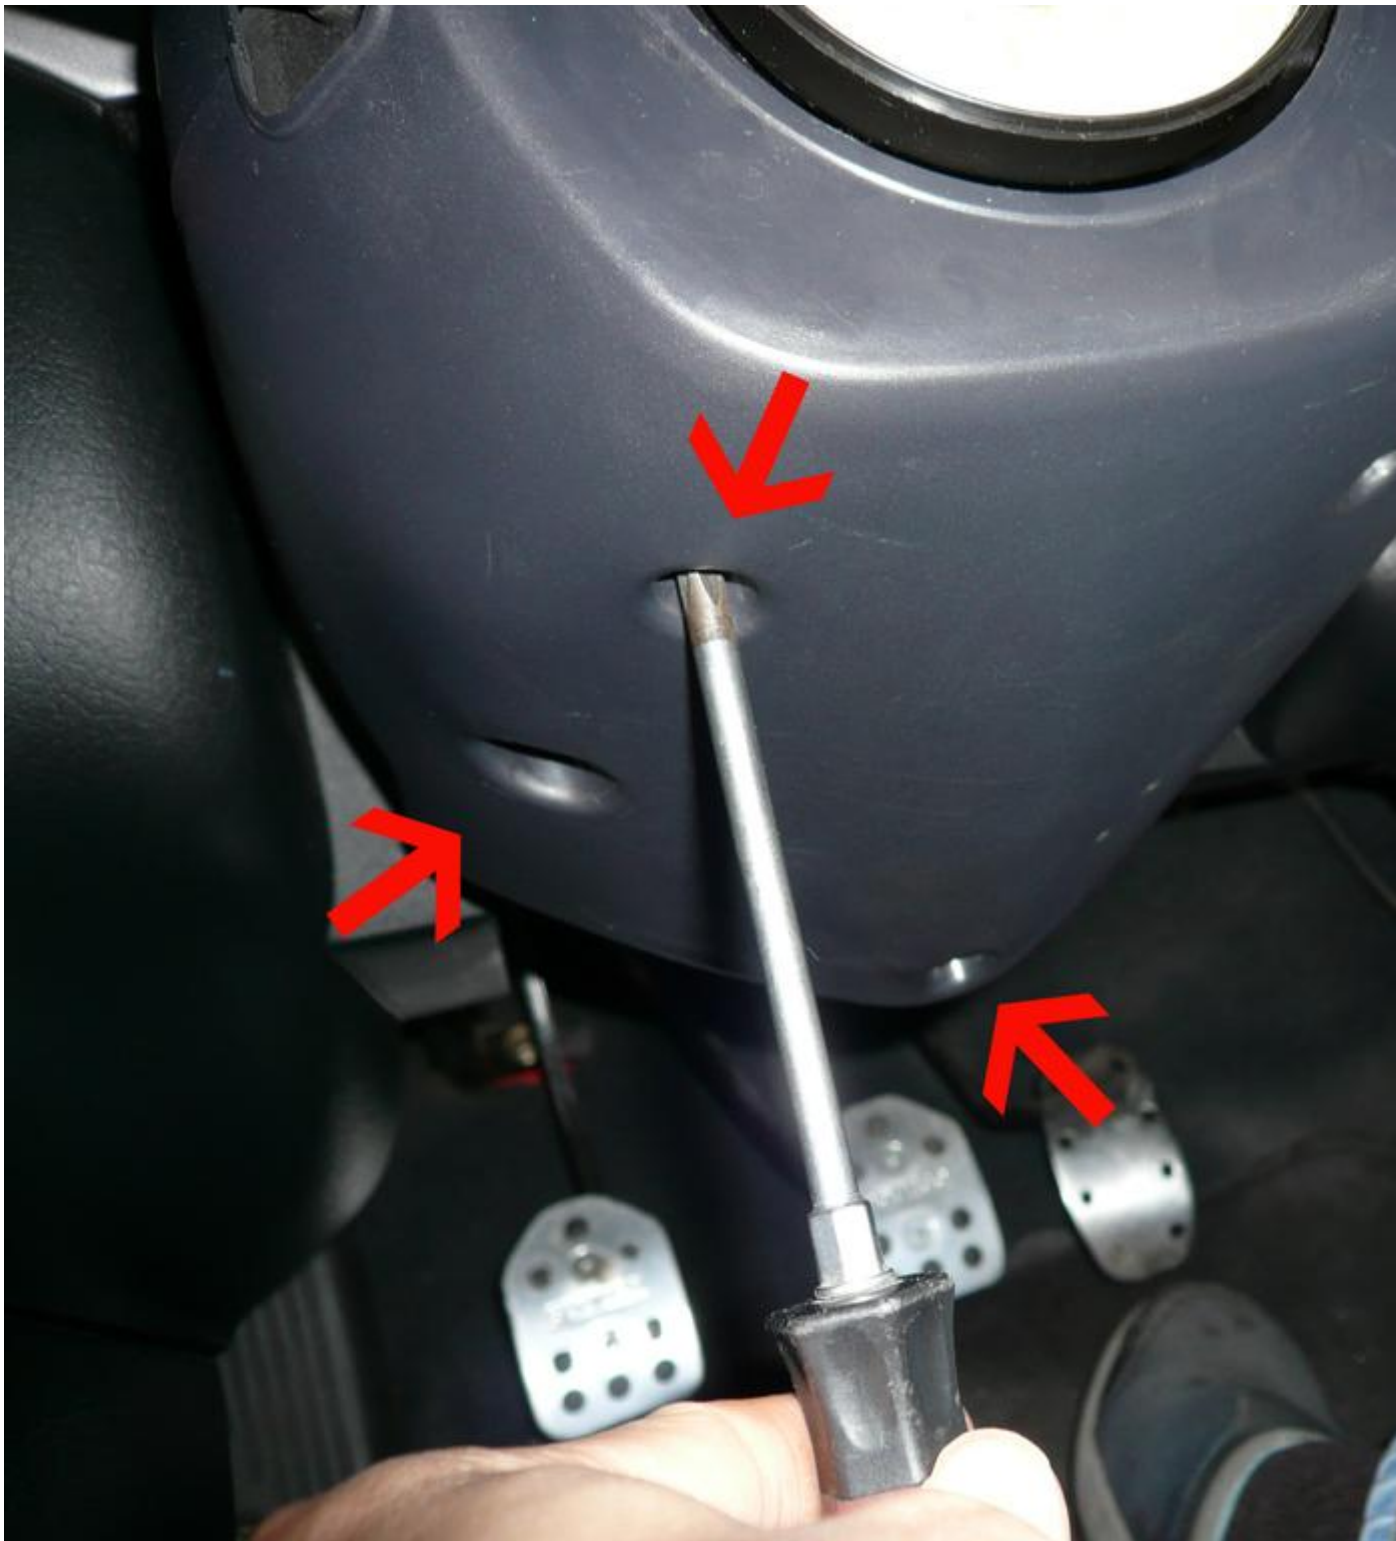
Once the wheel is off, remove the plastic cowling that covers the indicator stalks. Unscrew the 2 screws at the front using a Philips head screwdriver, and 4 other screws at the bottom.

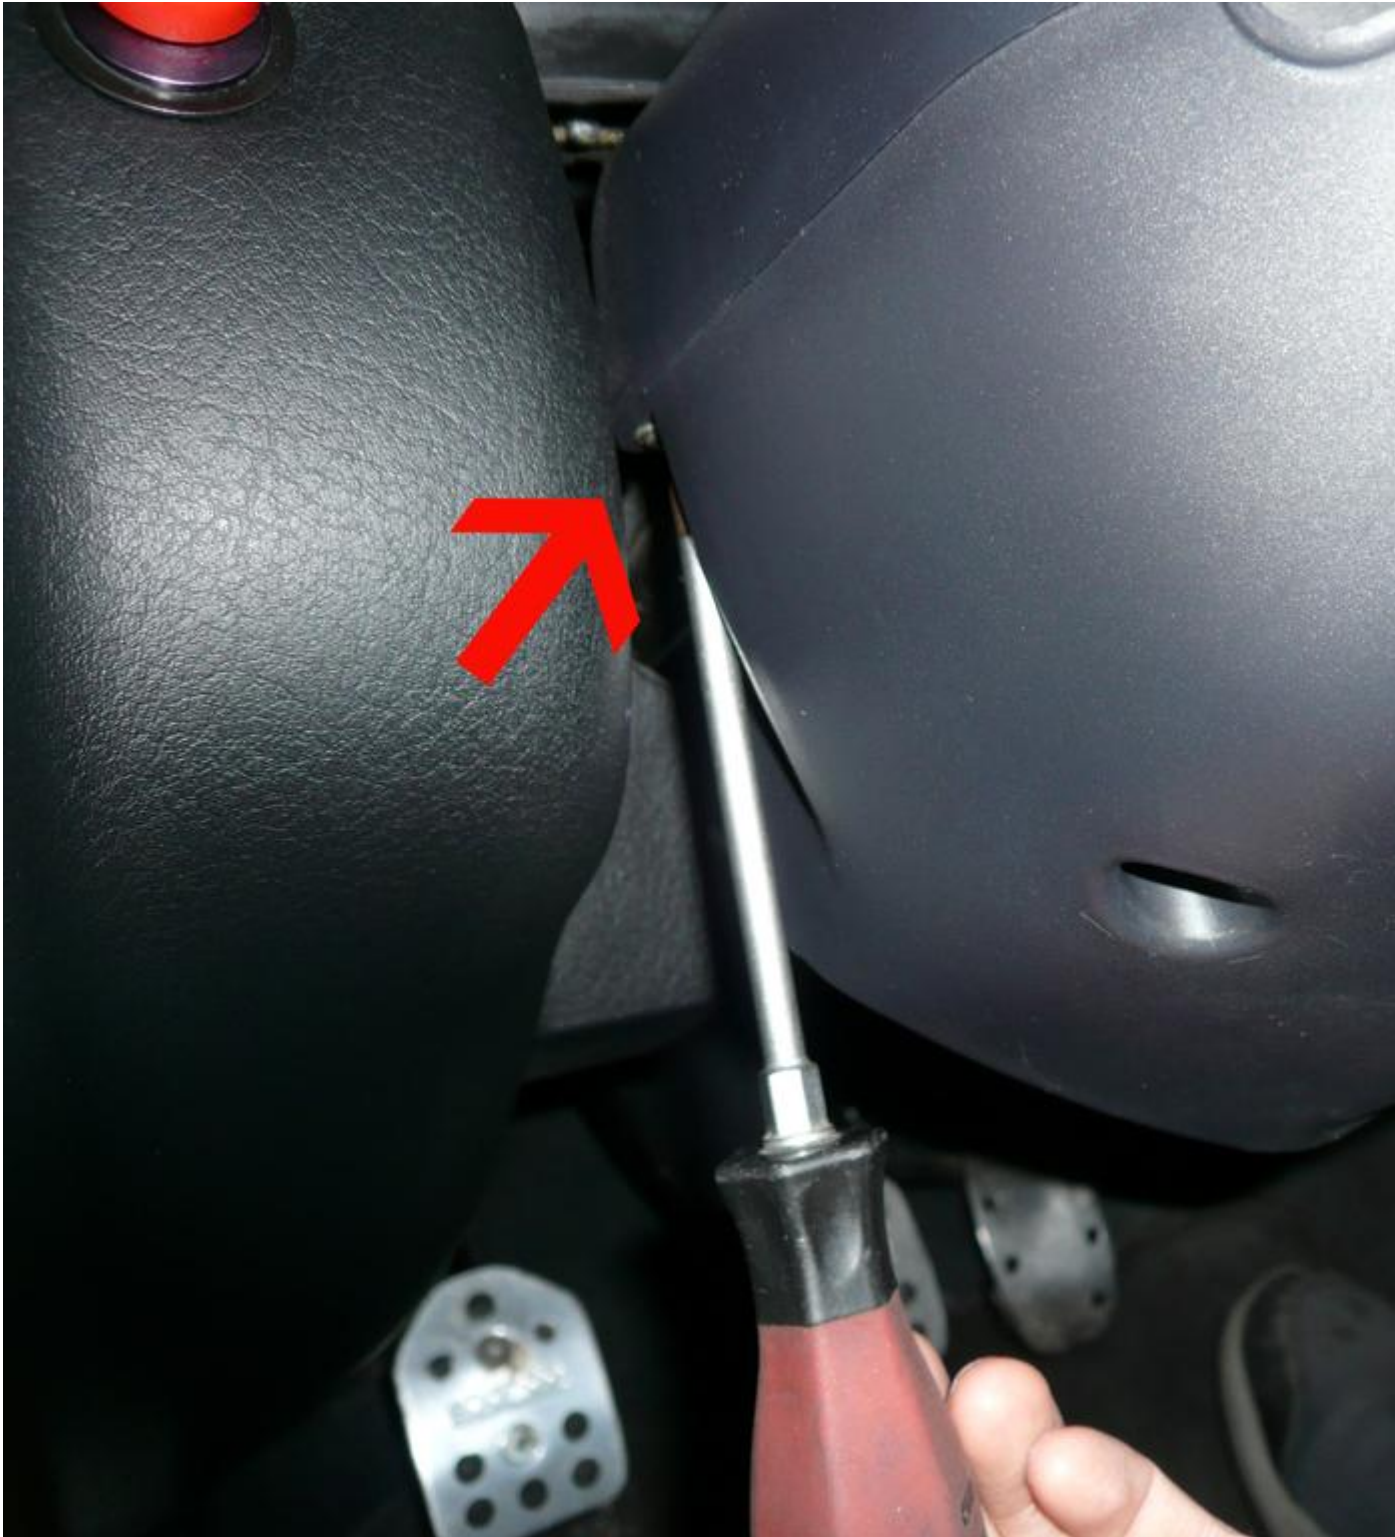
There are also 2 more screws at the sides which are well hidden shown here.

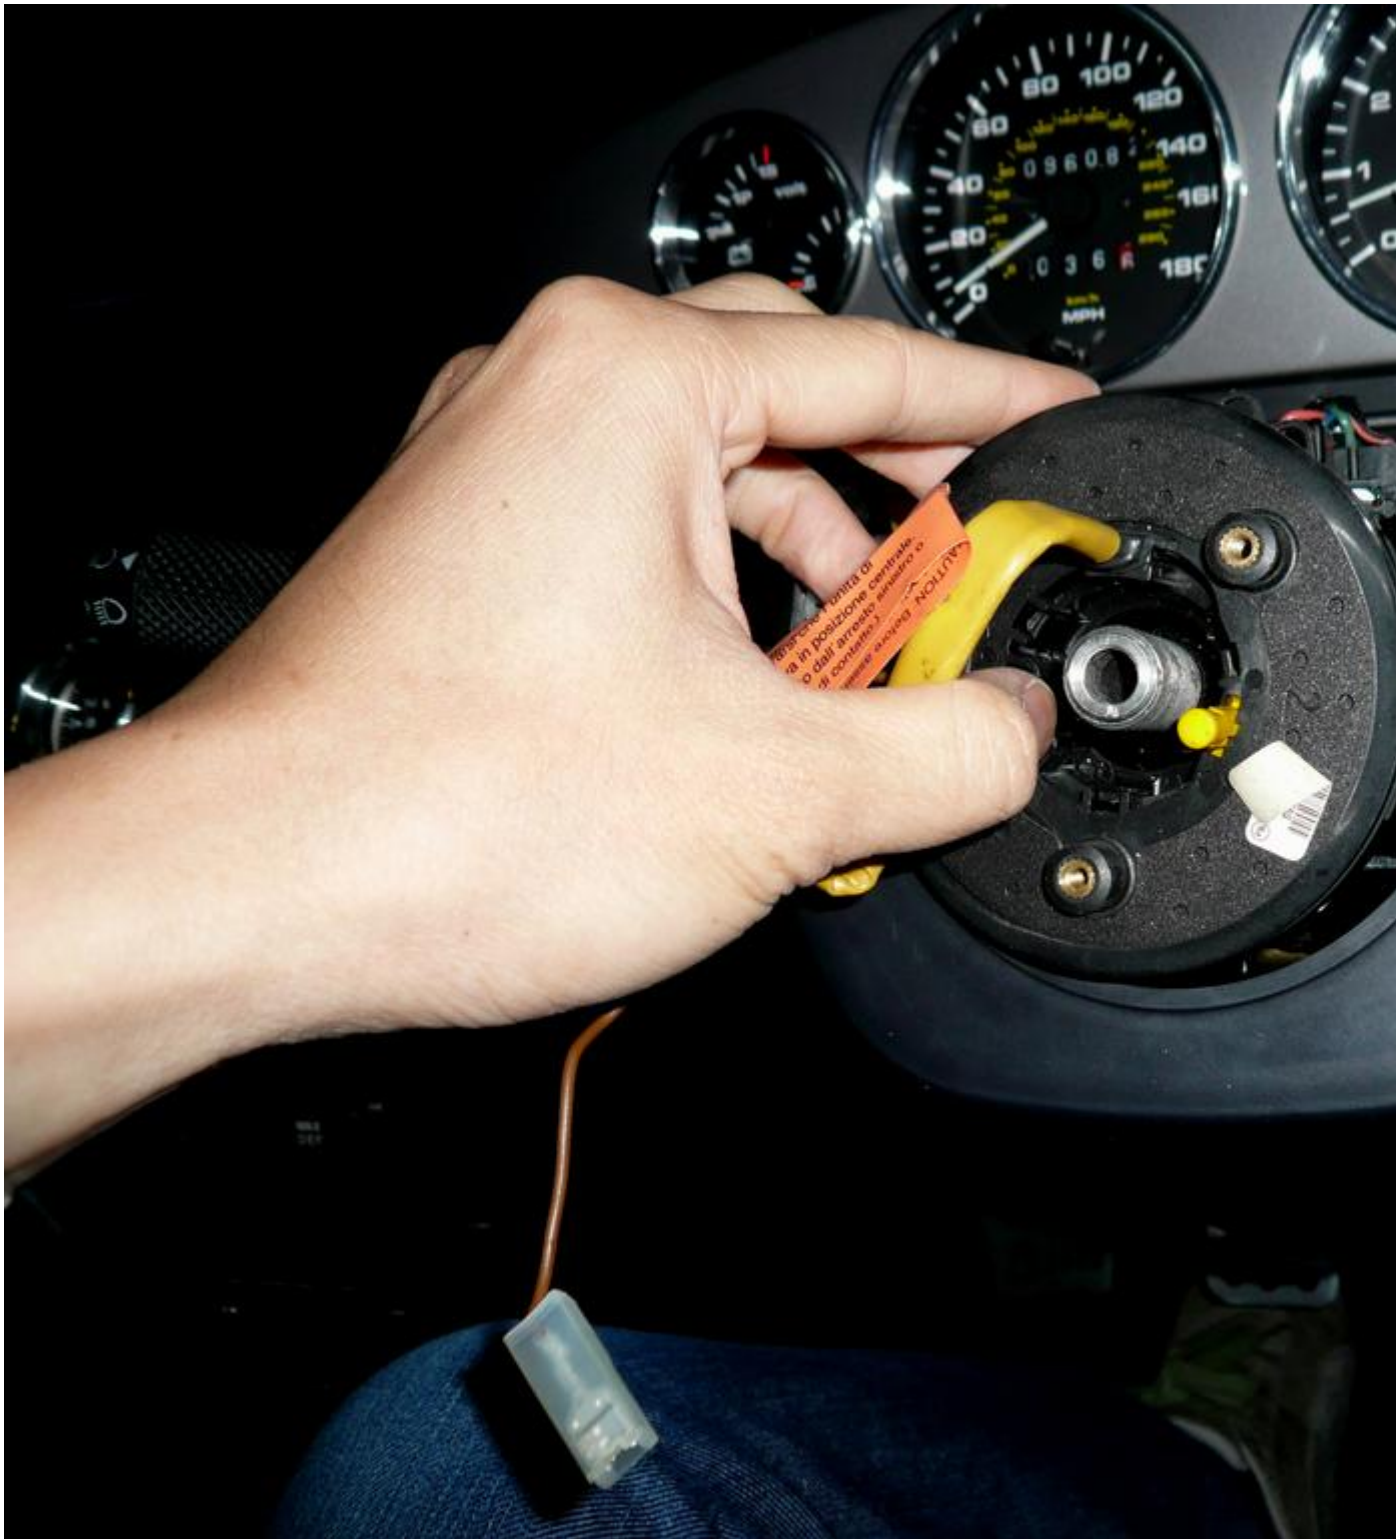
With the Cowlings removed, lift off the clock-spring from the steering column.

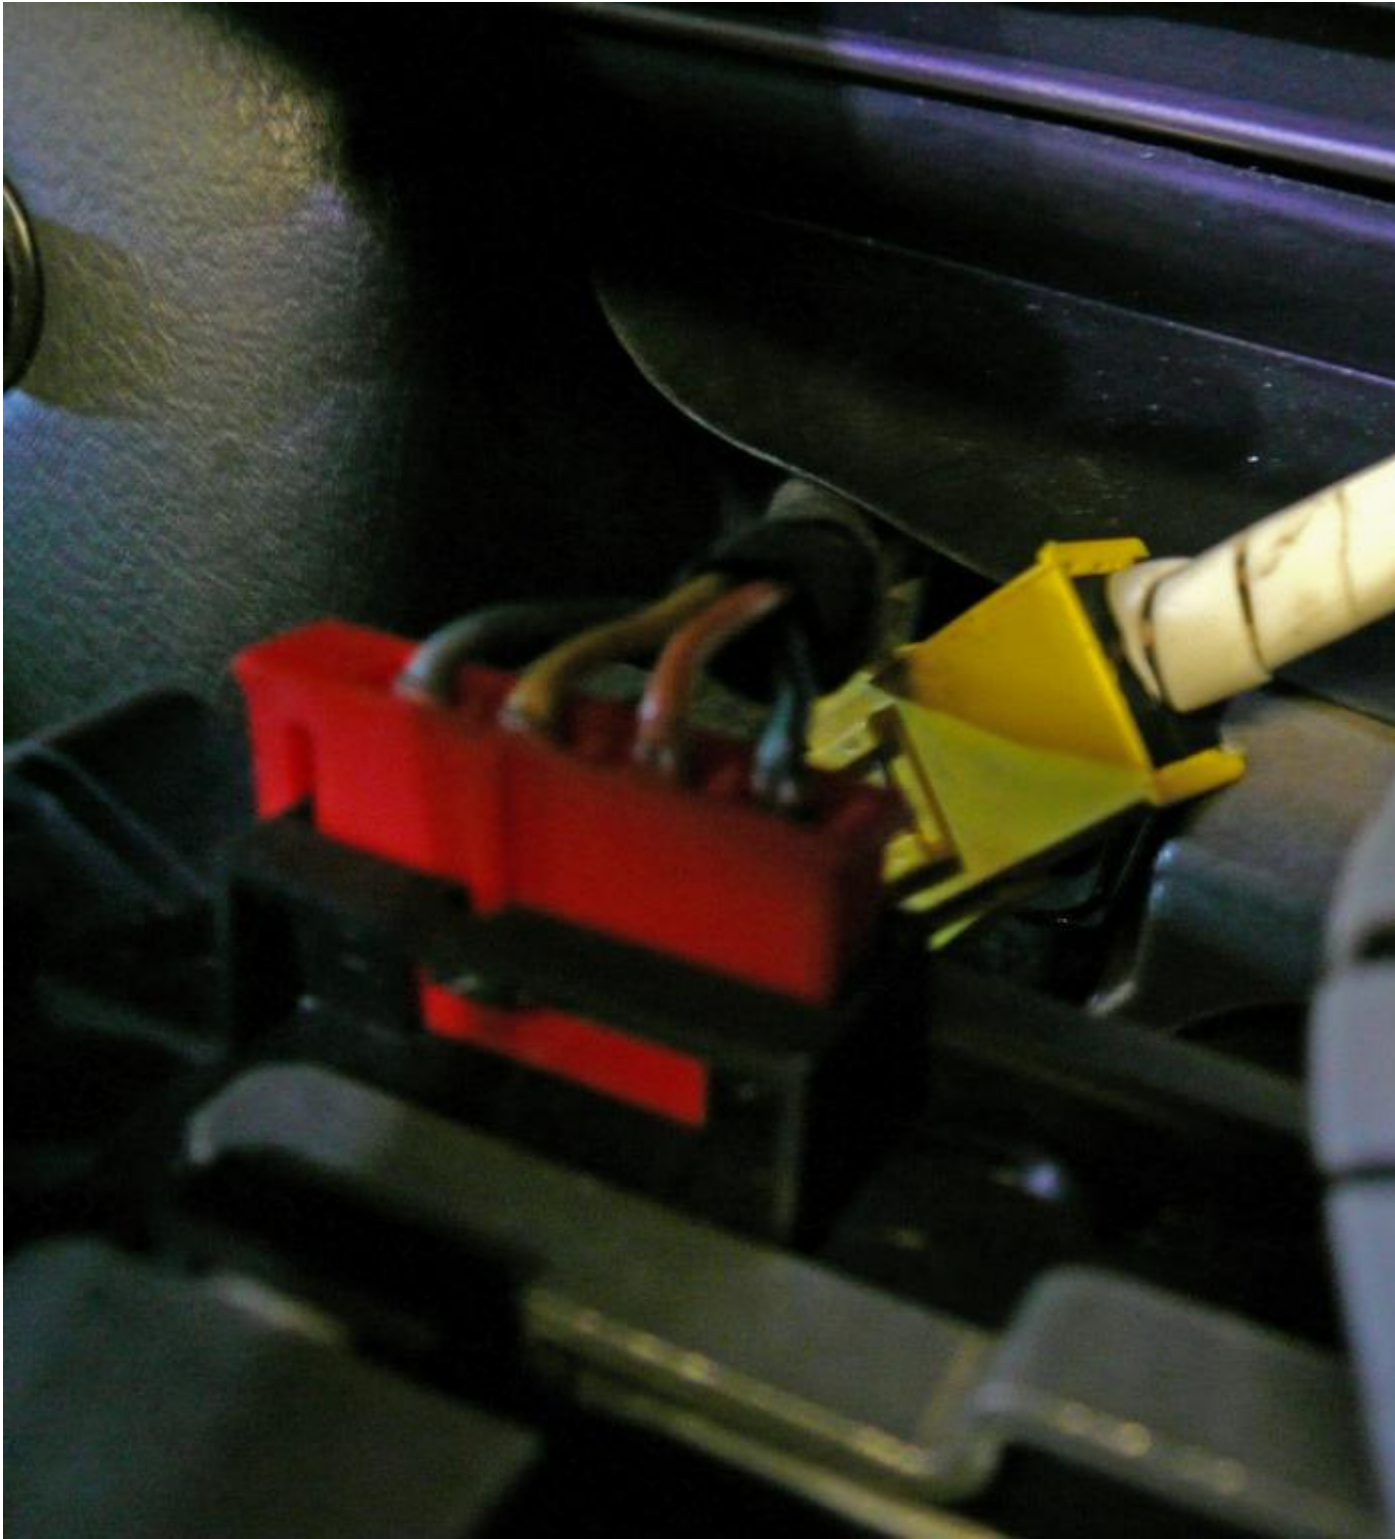
You can either push the clock-spring aside and leave it connected or remove it completely by unplugging the yellow socket that is found at the top of the indicator console shown here.

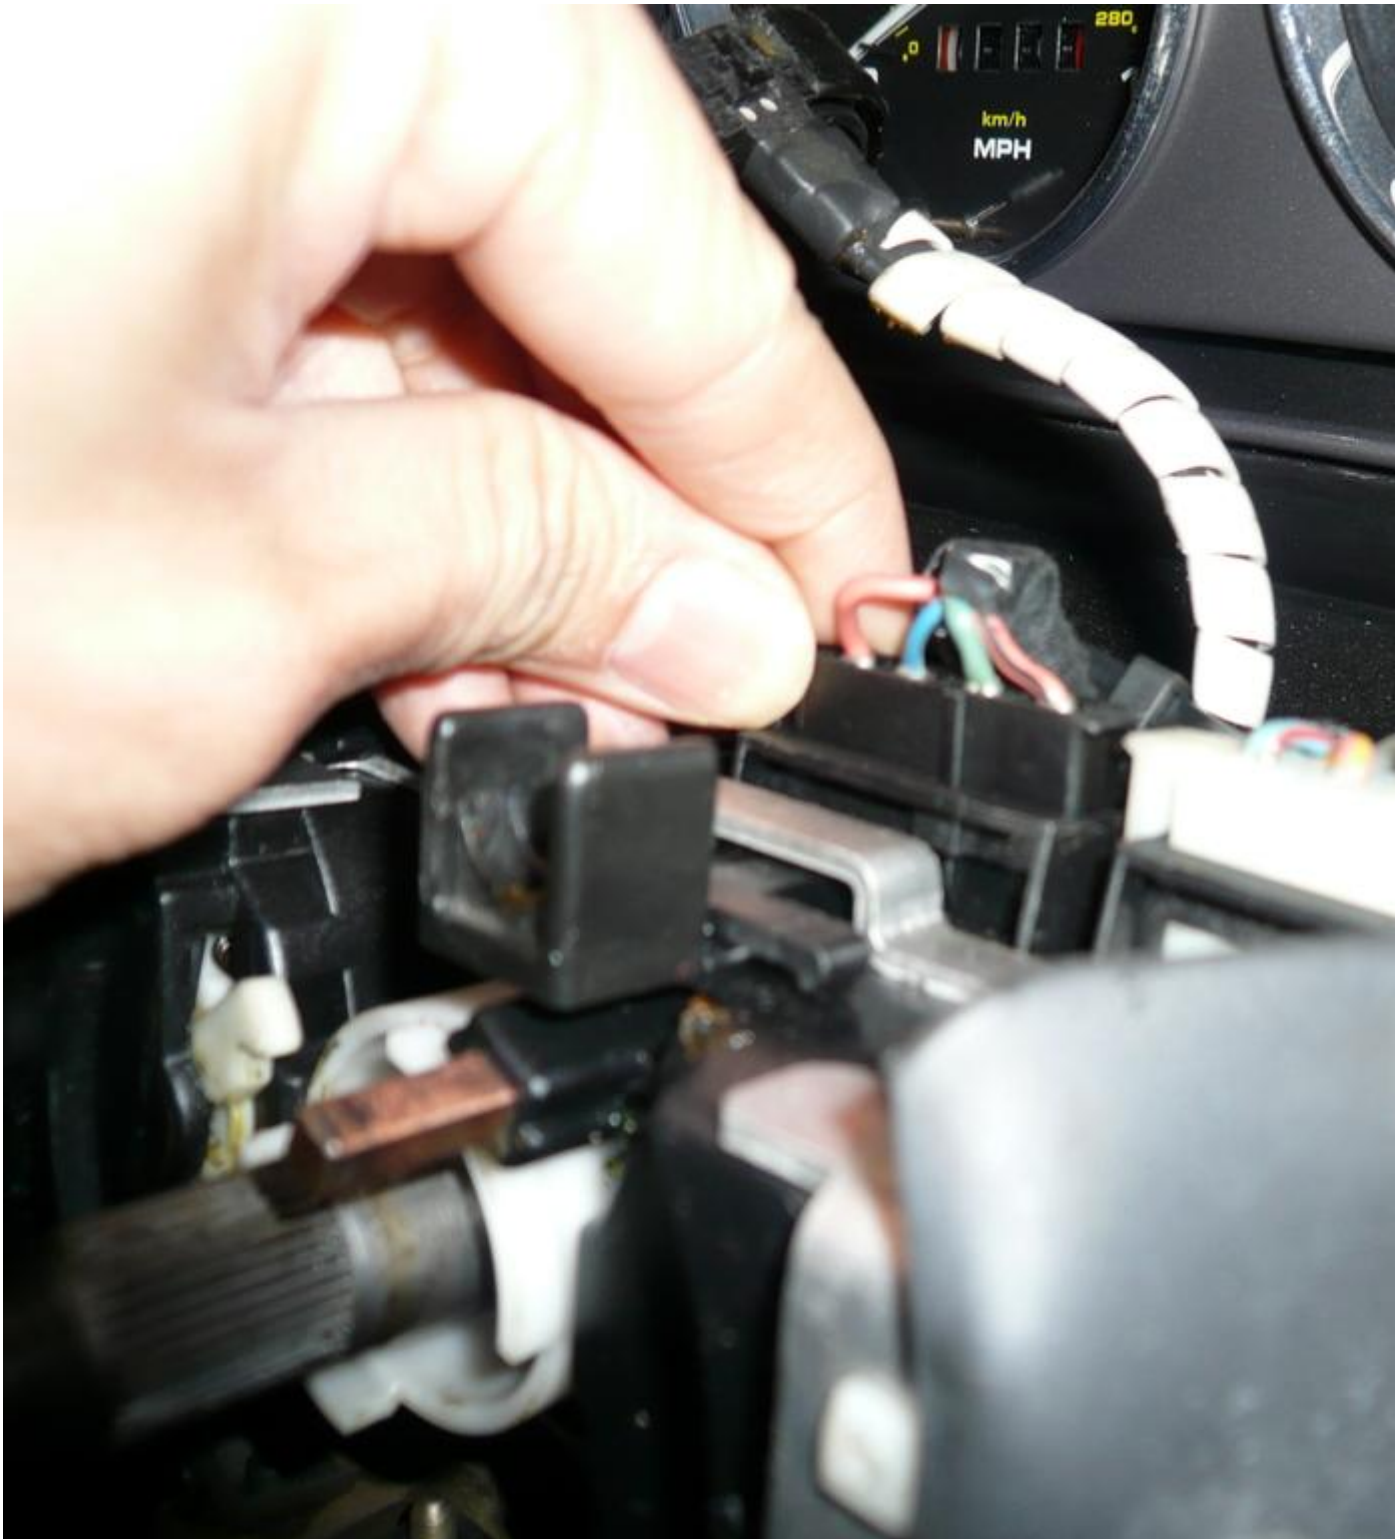
The exposed indicator console can now be removed by firstly unplugging the 5 electrical connectors that go to it

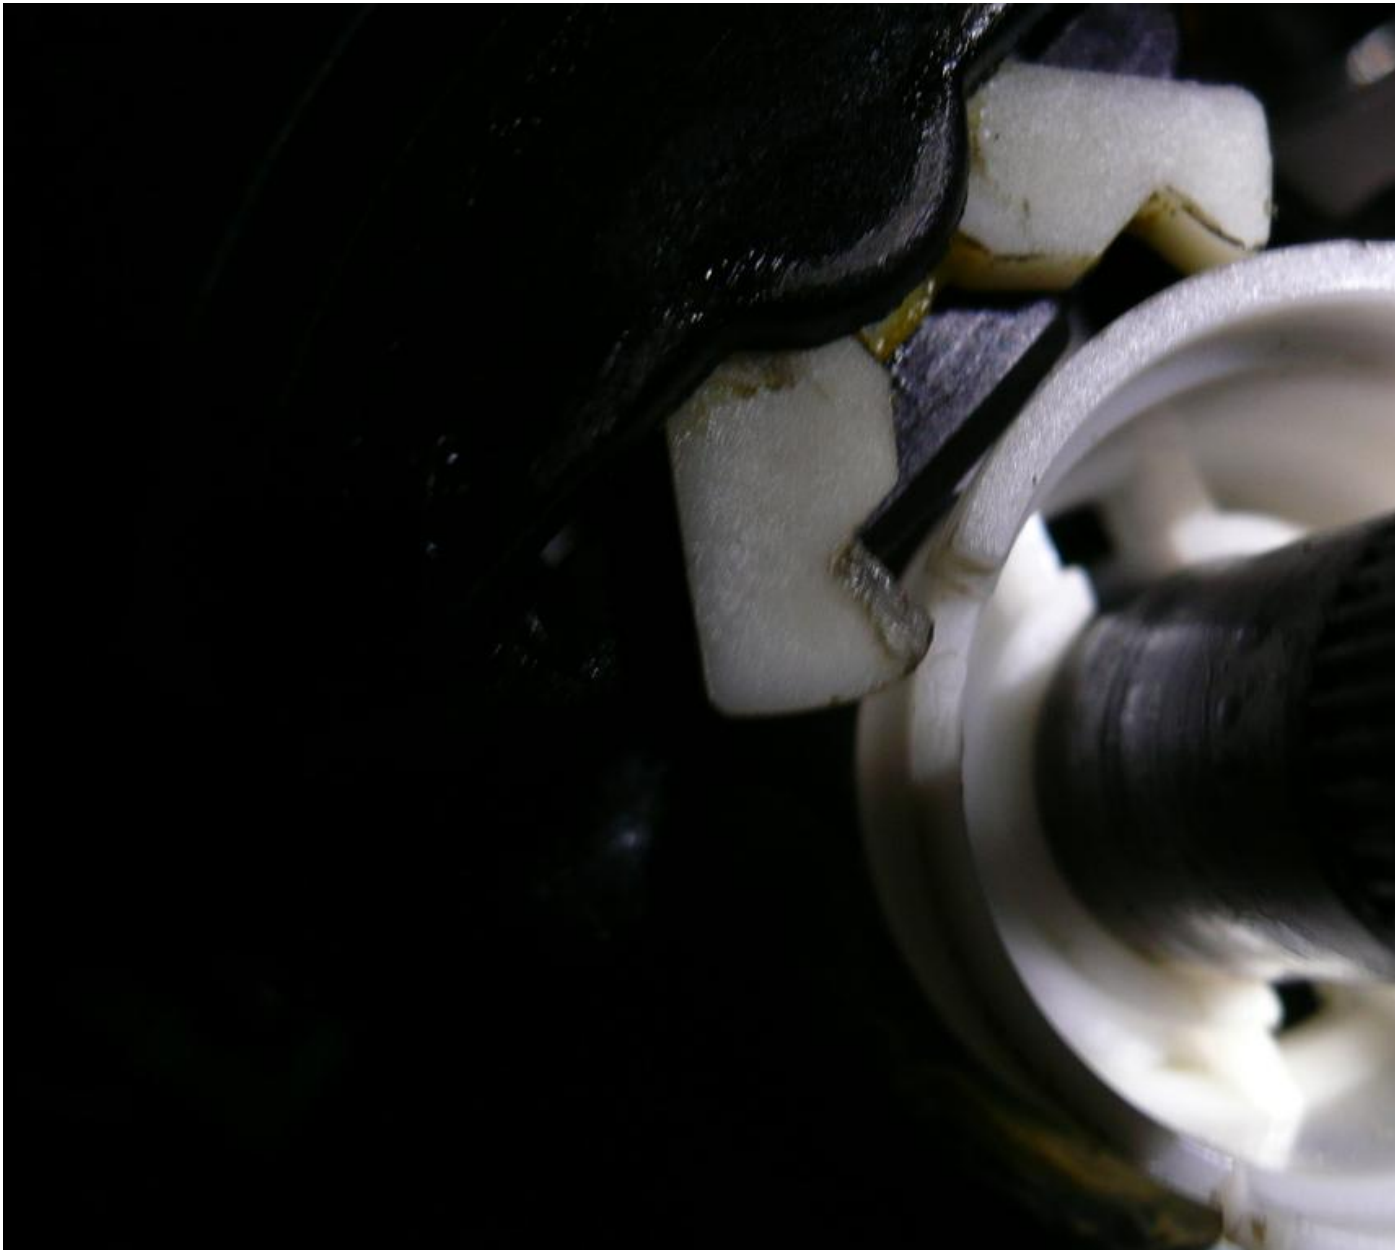
Once you have stuck on the plastic, leave it to dry fully then try rotating the collar to make sure it pushes the tab smoothly. You might need to file the edges down a bit in order to prevent it from jamming and to achieve a smooth self-cancelling motion. This picture shows the bottom tab that I have thickened.
