## **Coupe Rear Brakes & Handbrake Cable guide and FAQ - all models**

## Fitting new Cables

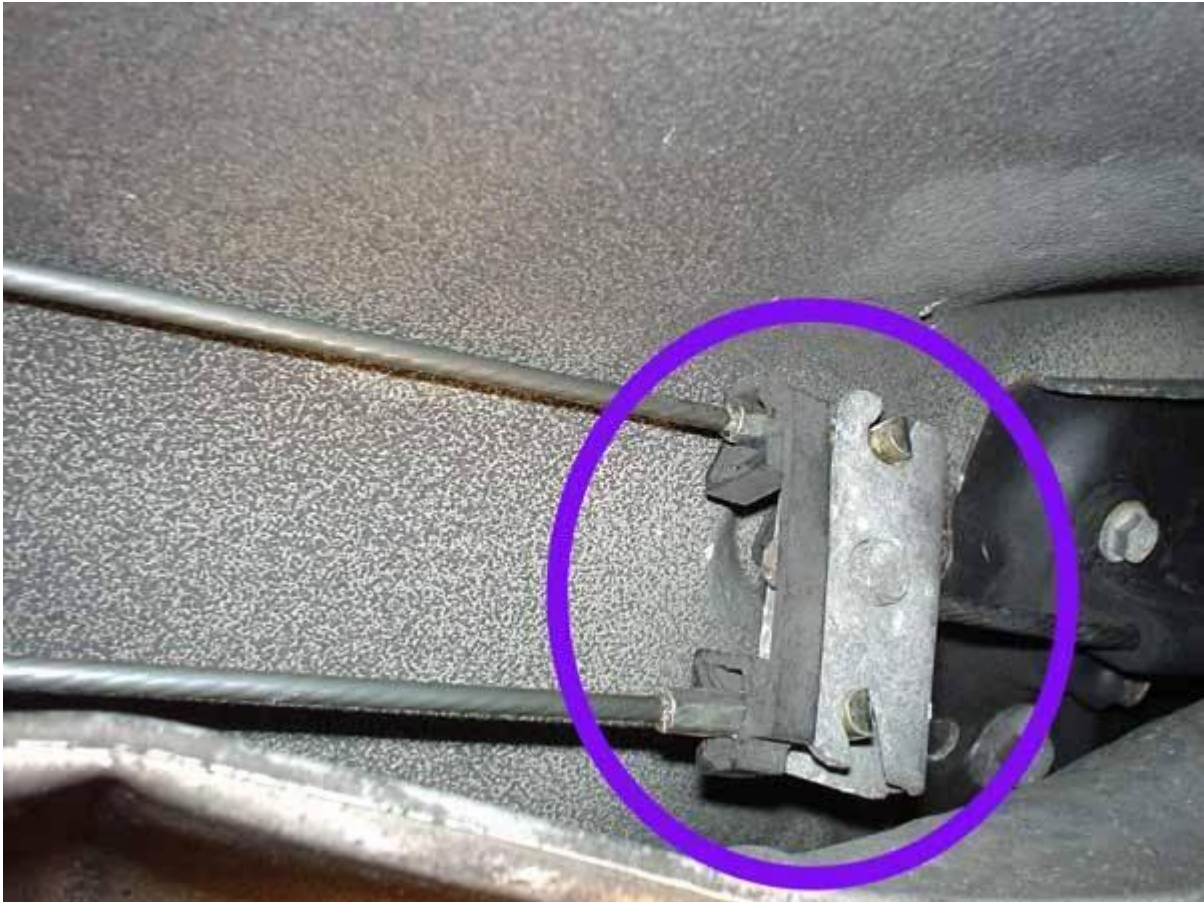
Next, slacken the handbrake tensioner located just below the lever. Turn the nut almost to the end of its thread but don't undo it completely.

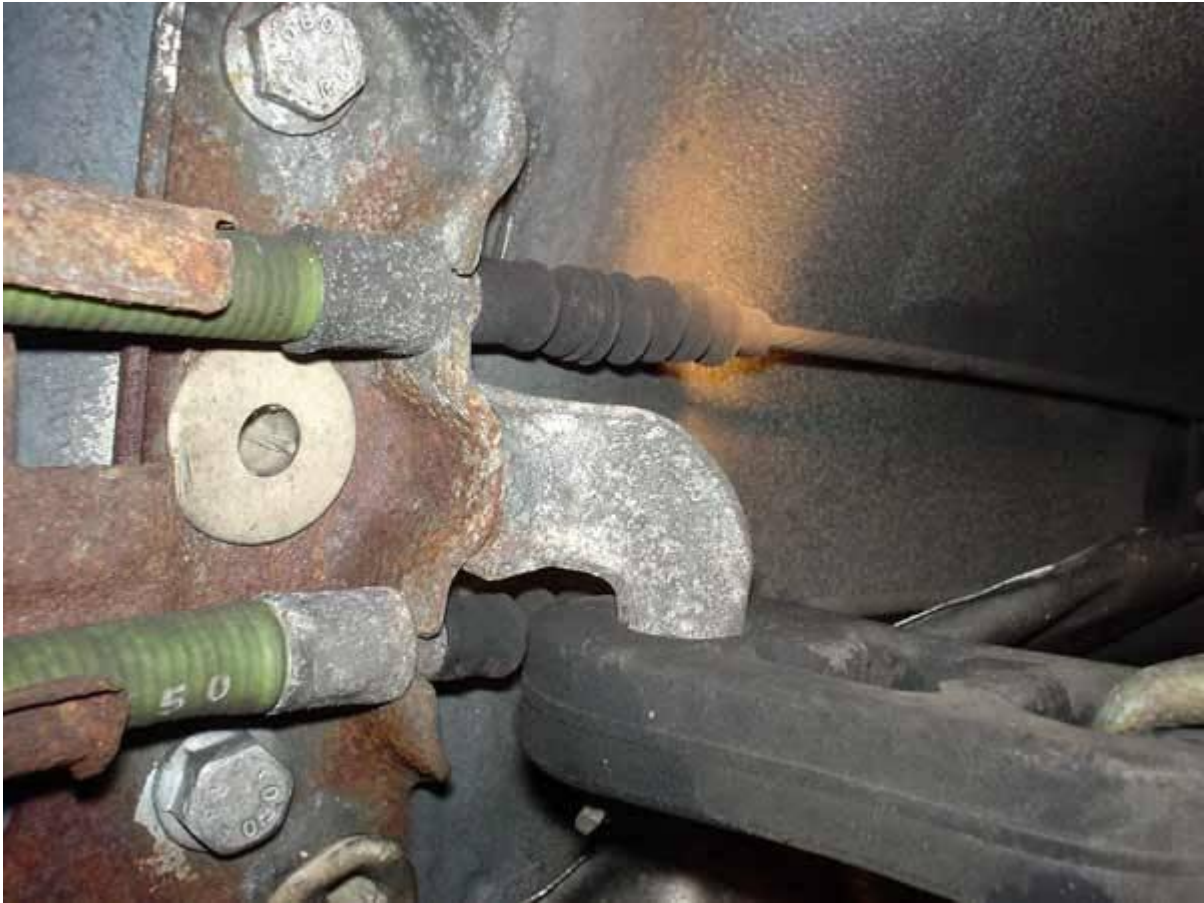
Now release the ends of the cables from the tie bar. This is in the middle of the car underneath and is easily accessible. Just remove the plastic clip and turn the cable ends out of the slots.

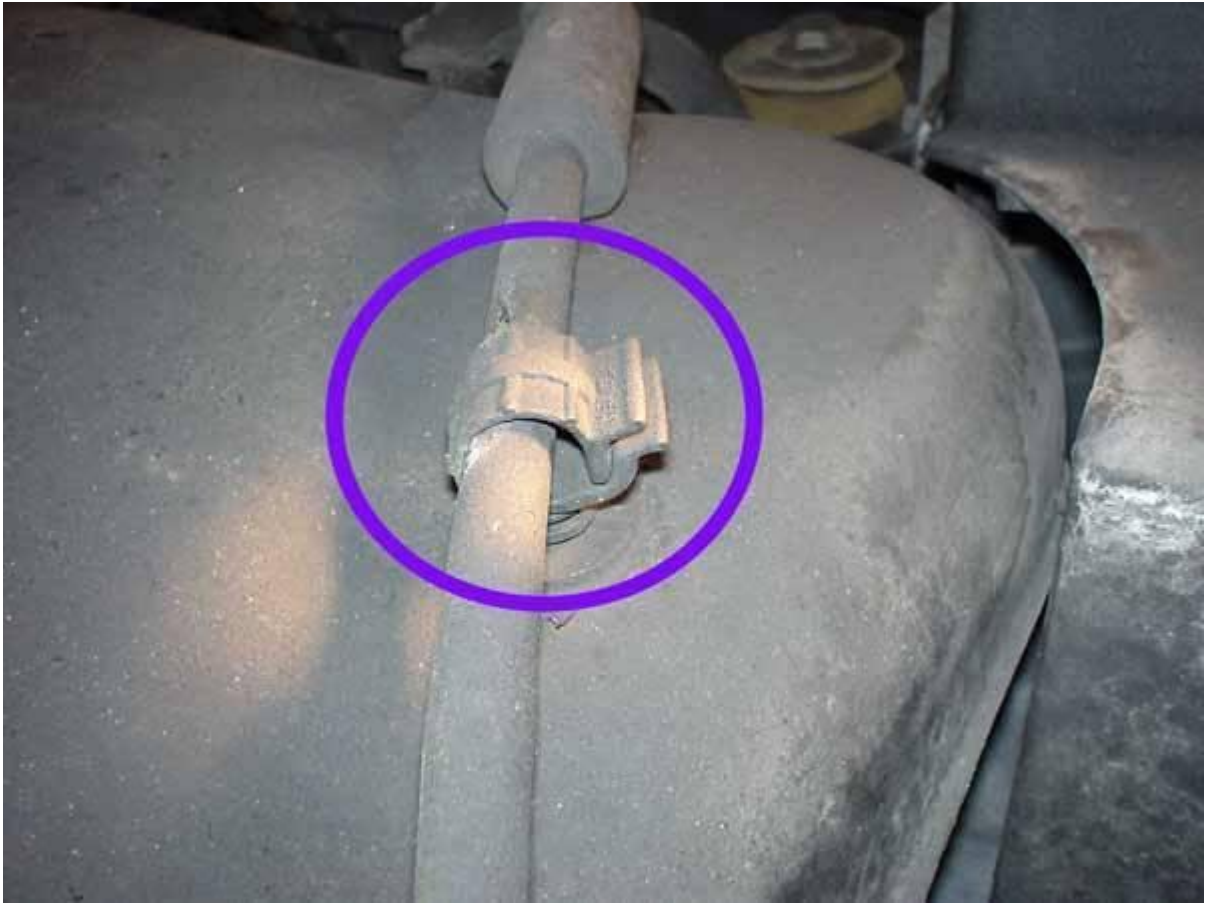
Working towards the rear of the car, simply pull the cable assembly rearwards from these supports.

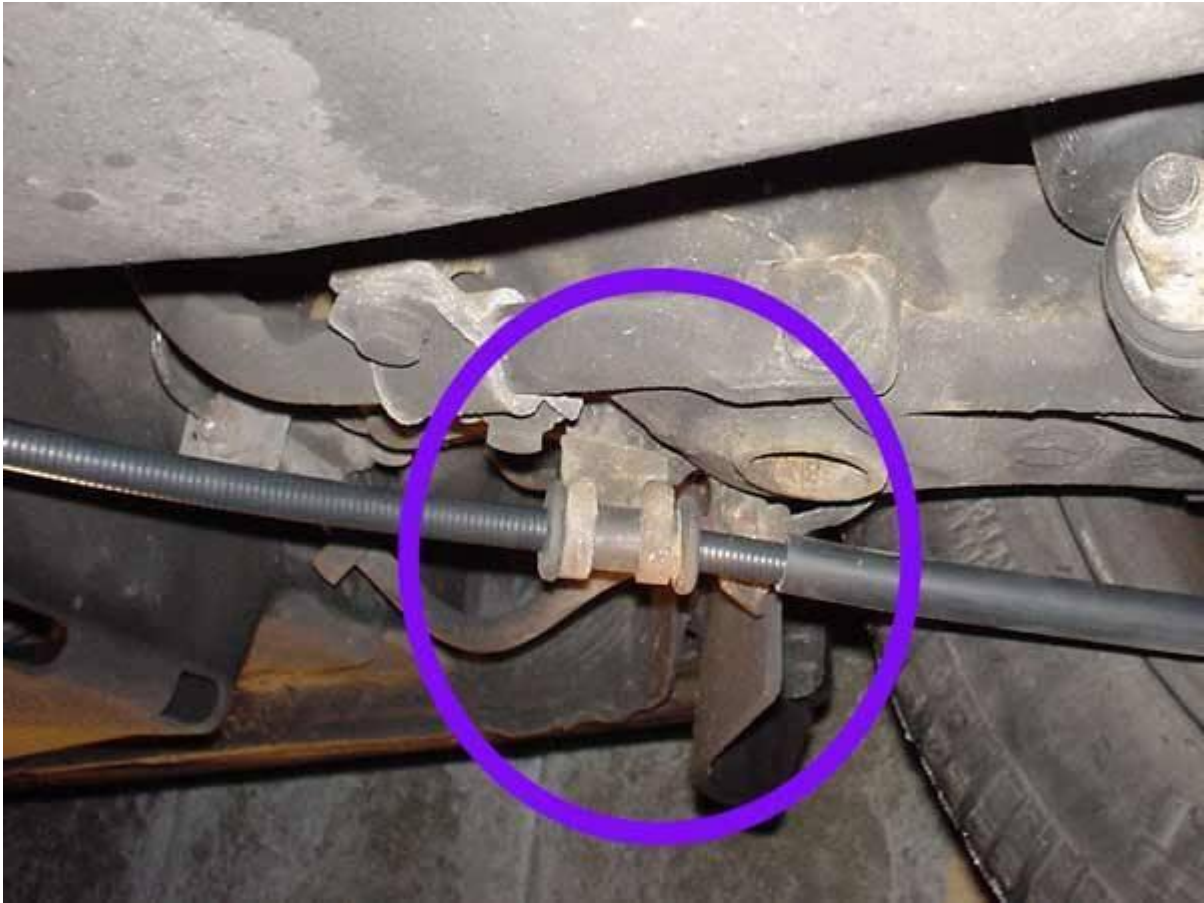
On each side of the car working rearwards you'll come across a clip like this. Simply prise it open with your fingers.

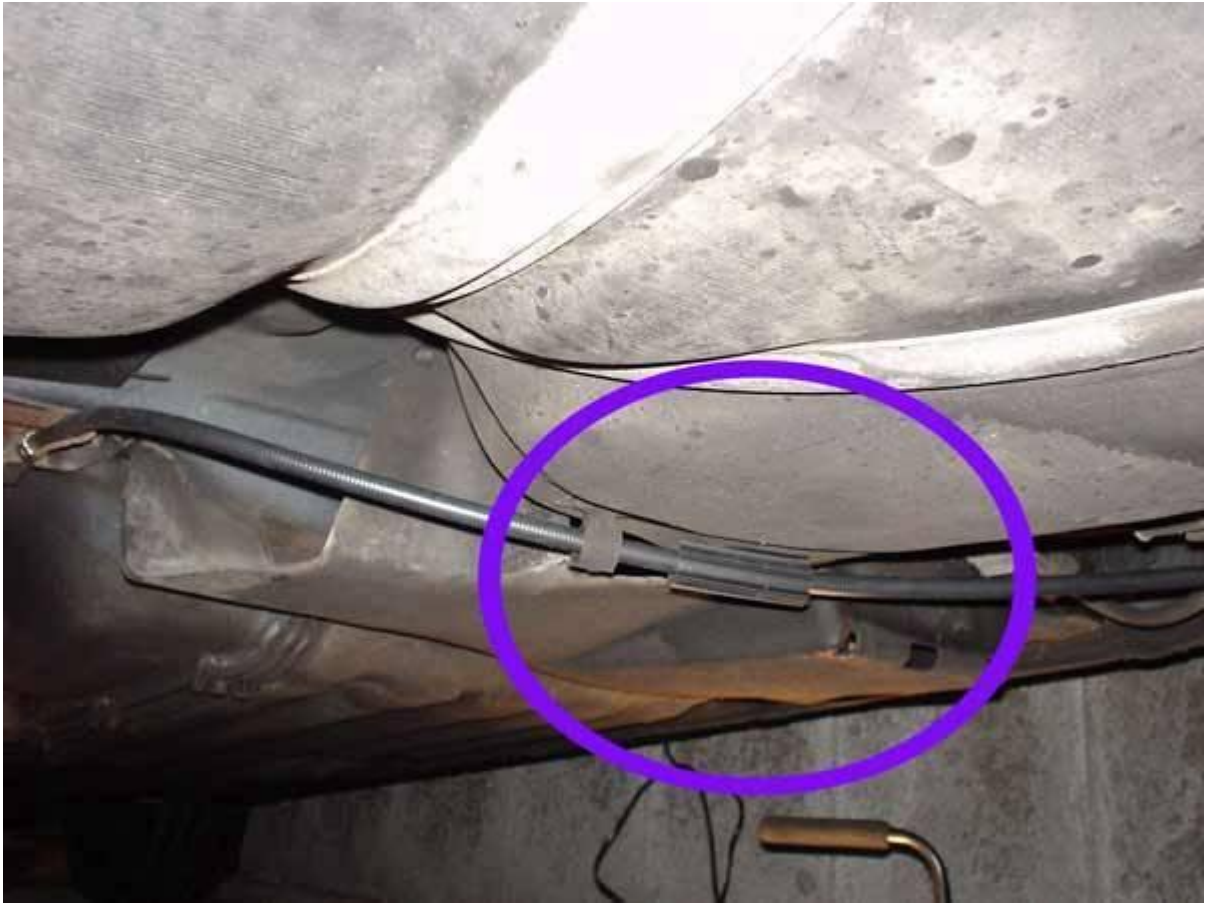
Also on both sides of the car you'll find these supports. The cable sits in them but you'll need to unbolt the 13mm bolt that holds the supports' bracket on to make room to slip the cable out.

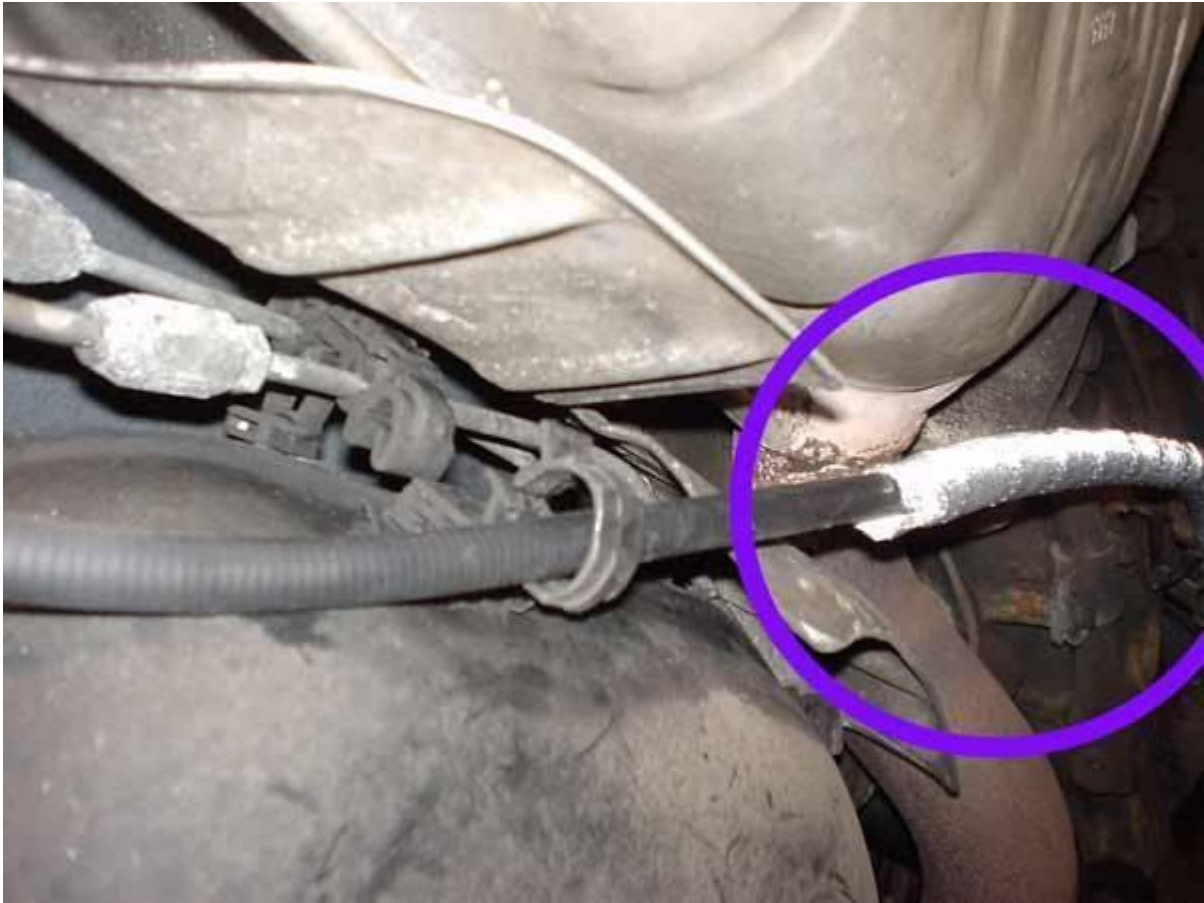
On the side of the car away from the exhaust you'll find this small free moving plastic widget. This stops the cable chafing on the tank.

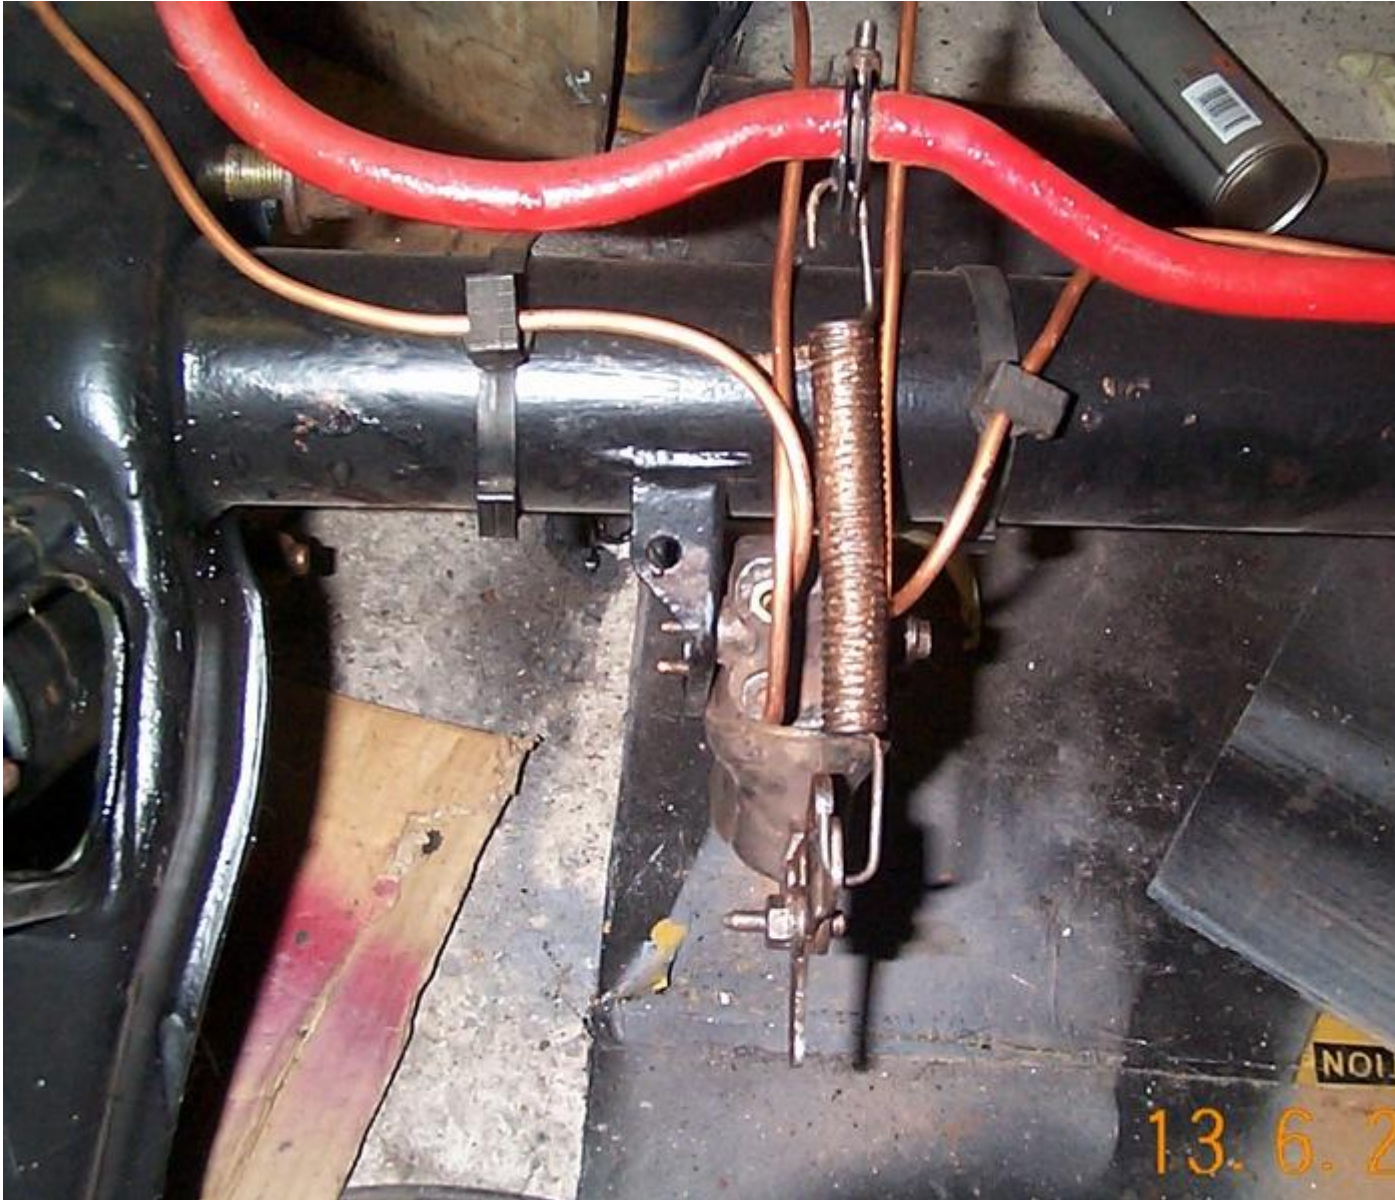
The Brake Compensator valve is attached to the rear sub frame in the middle of the car behind the fuel tank. It is shrouded in a rubber boot but water can get in and cause the mechanism to seize.

Here is a photo of the item (subframe removed from the car, so viewed from above)

The idea is that under hard braking as the nose of the car dips, and the rear rises, the valve reduces pressure to the rear callipers to prevent the brakes from locking. So if the valve has seized in this position foot brake efficiency at the MOT will be poor. It is worth checking the condition of the rubber boot occasionally and giving the area behind the boot a good spray of copper grease every year or so..

- Support the rear on axle stands underneath each shock (or have the car on ramps). Take the spring and rubber boot off the compensator and remove the centre shaft and washer. Wire brush the lever to clean it up a bit and free the adjustment bolt. With the help of pliers, WD40 and a rag, clean up the centre shaft and two valve pistons

- Apply new copper grease to everything
- Reassemble
