## **Refurbishing the Fuel Filler Cap**

The fuel filler cap on the coupé is notorious for degrading over time. When the cars left the factory originally, the cap was lacquered but now the lacquer is starting to fail and allows moisture to create areas of corrosion.

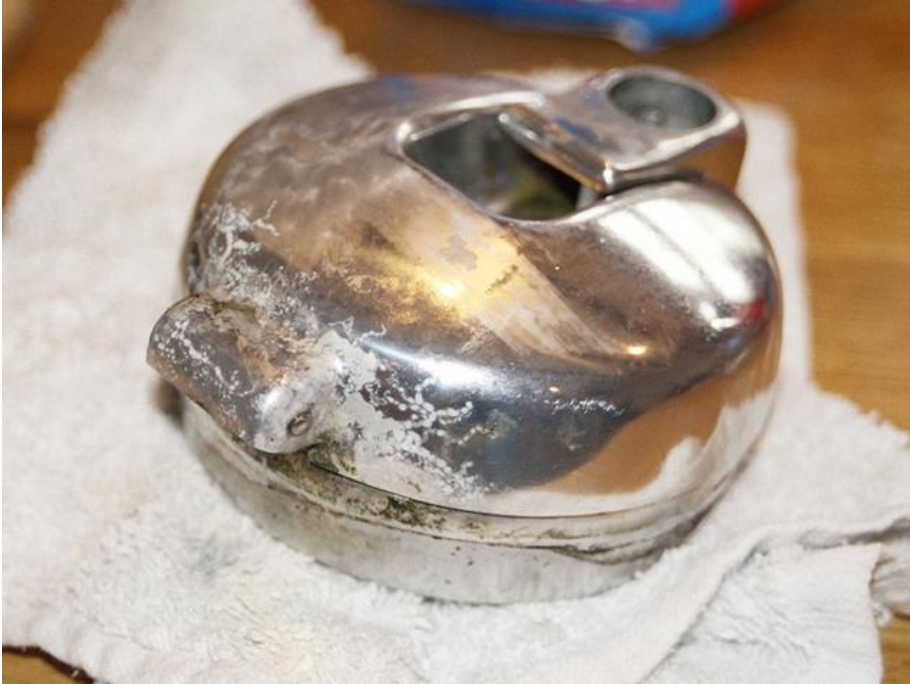
- Covered in Nitromors

- This is what it will look like after twenty minutes.

1. Paint Nitromors or similar paint stripper solution, with small brush all over the cap, following the directions and safety advice from the manufacturer.

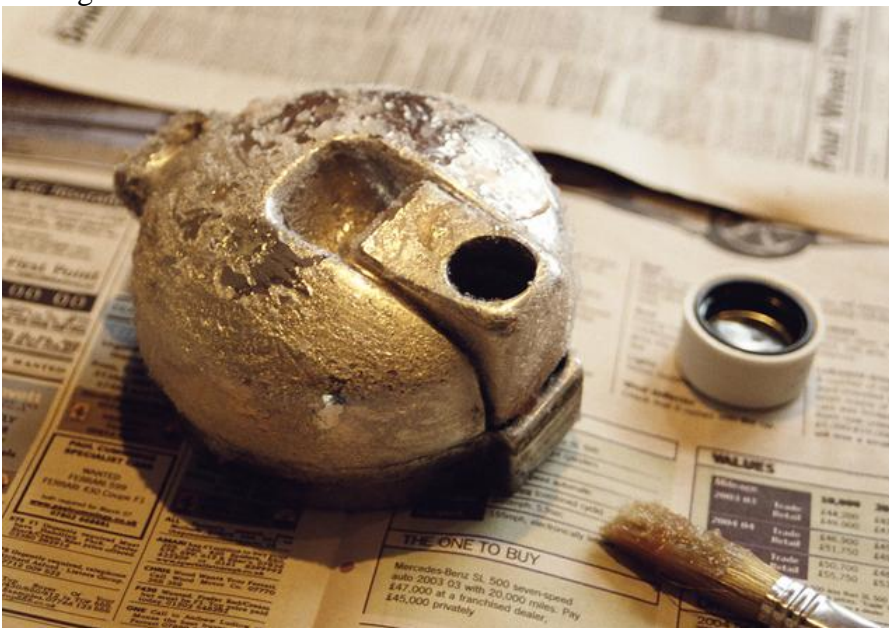
- Getting there

- Wire wool the paint stripper (wearing gloves and eye protection). It should clean it up a treat and eases off the remaining lacquer.
- If there is remaining lacquer repeat the process.

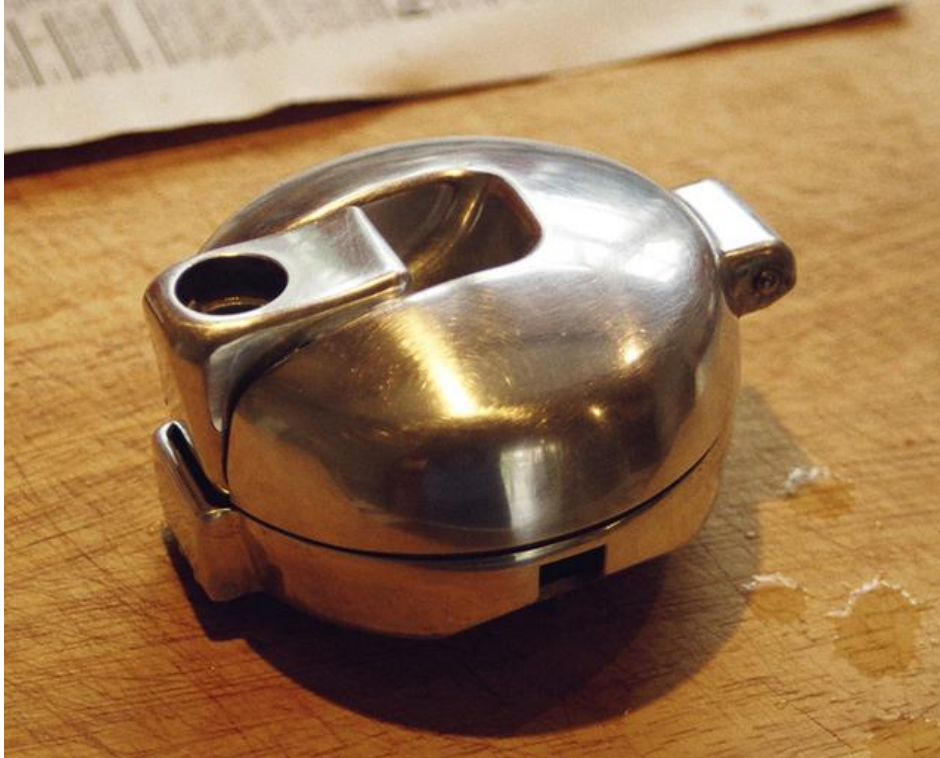
Clear of lacquer

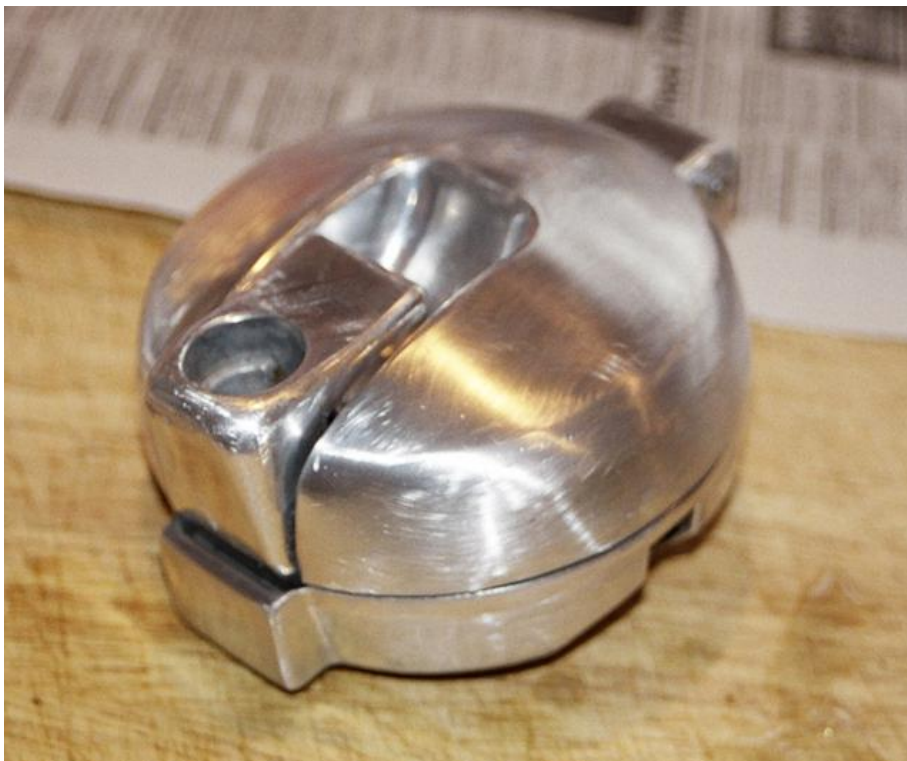
7. Sand the bare cap with 600 and then 1200 wet and dry grit paper.  
Sanded

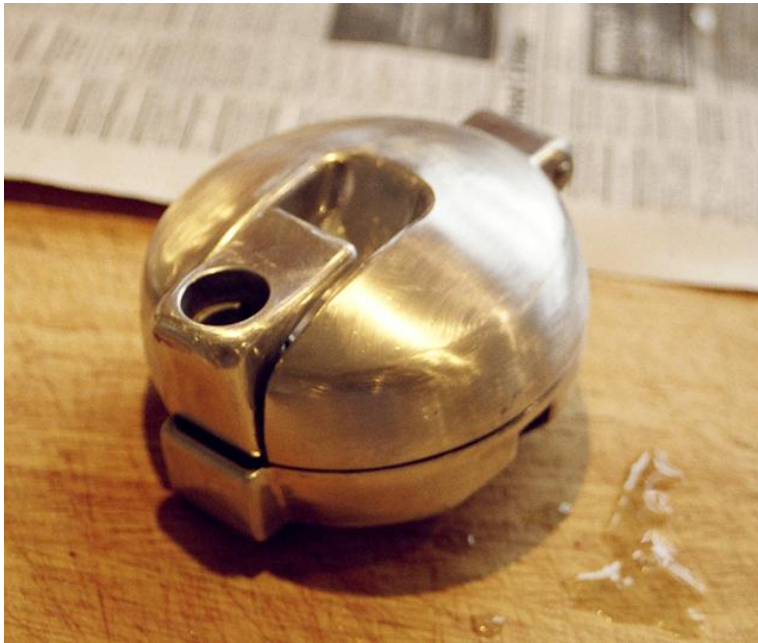
8. An alternative to sandpaper is to use wire wool and Autosol chrome polish. As you can see the sand paper does leave a lot of scratching.

This is after a go with the wire wool and Autosol

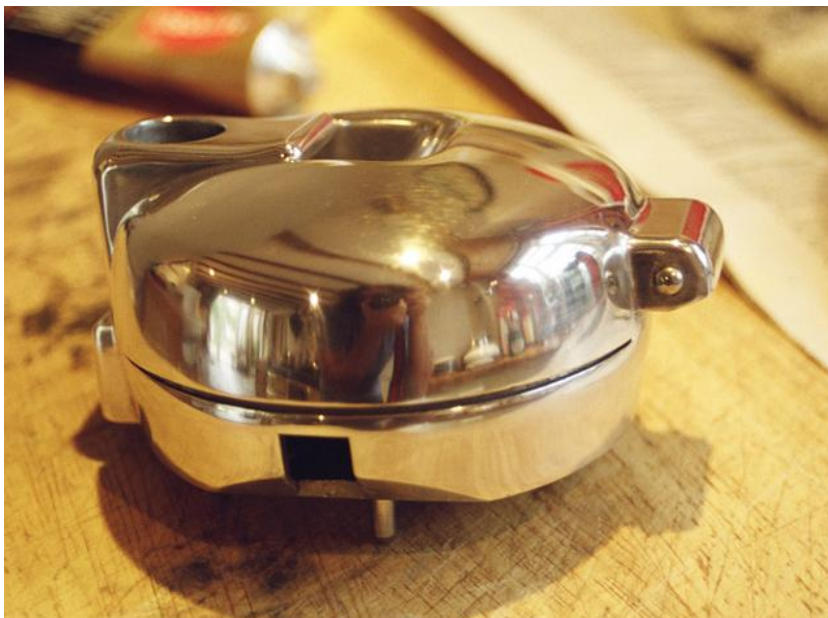
#### **The After picture**

The Autosol feels gritty as you work it in but then starts to smooth out in to a dark covering. Apply some more and keep going until you are happy with the finish.

This cap was then waxed to protect it, Carnauba Wax by DT  
It can take about 2 hours including removal/refitting of the cap.

9. With a slightly damp cloth and Autosol start rubbing.
