[Oil cooler and cooler pipes replacement 20valve Turbo.](#)

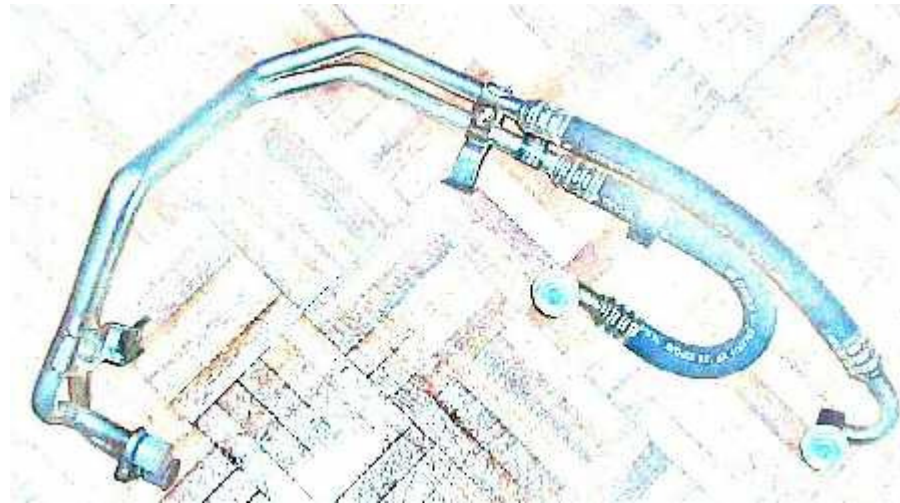
New pipes as they come (some problem with image) note exposed metal pipes on the left.

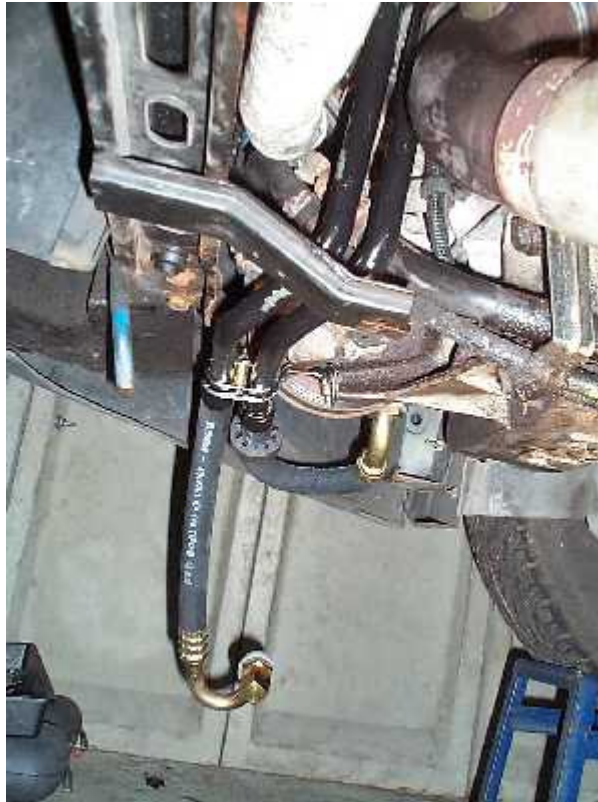
This shows the new pipes in place but disconnected from the oil cooler. Note the exposed metal has been painted black to prevent corrosion from re-occurring. It's just this lower exposed section that corrodes through.

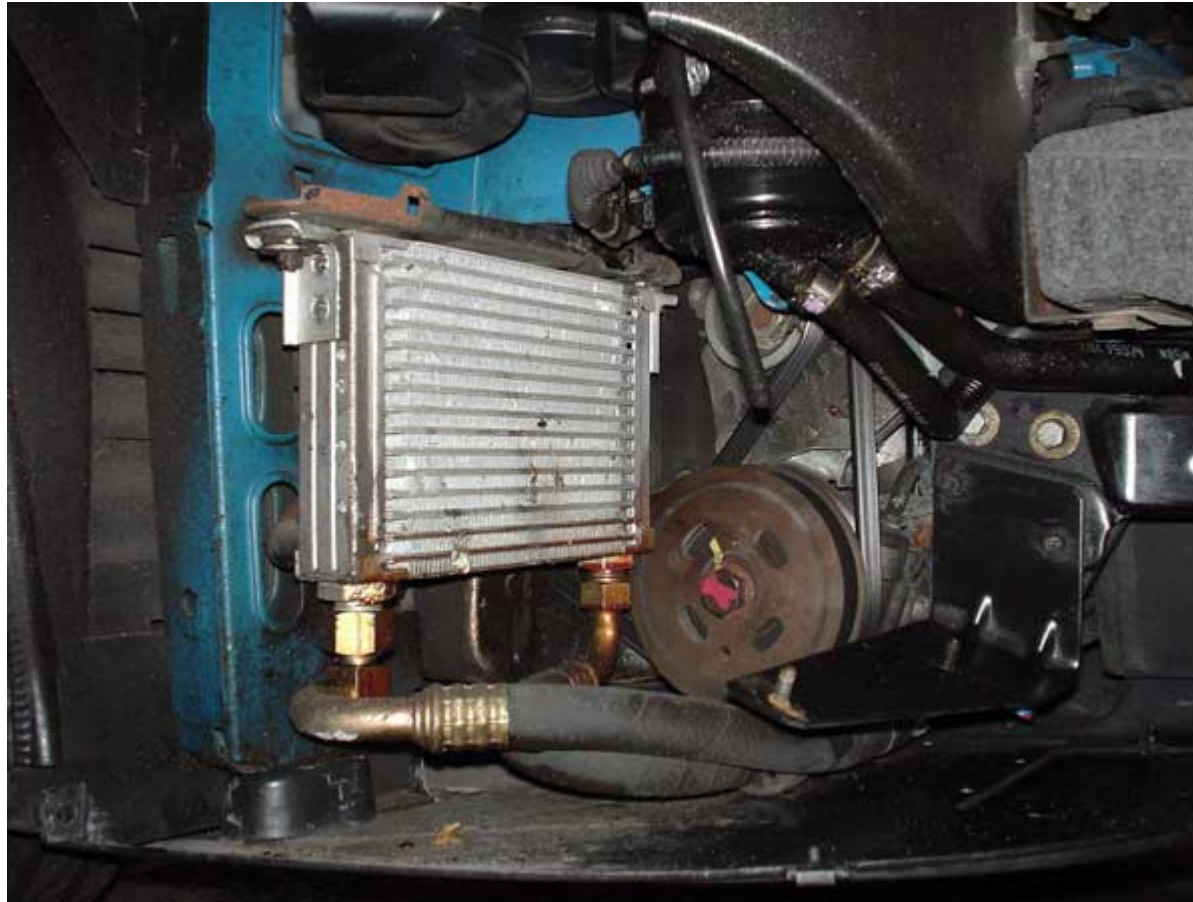
This photo taken with the front bumper removed and the oil cooler air vent removed. You can clearly see where the rubber part of the pipes rest on the undertray. The new pipes come with a protective rubber ring which must be positioned correctly to stop the pipes chafing. I've protected the joins from corrosion with a spray on corrosion inhibitor. This cooler has been fitted for less than a year and already you can see the impact damage from stones and insects!

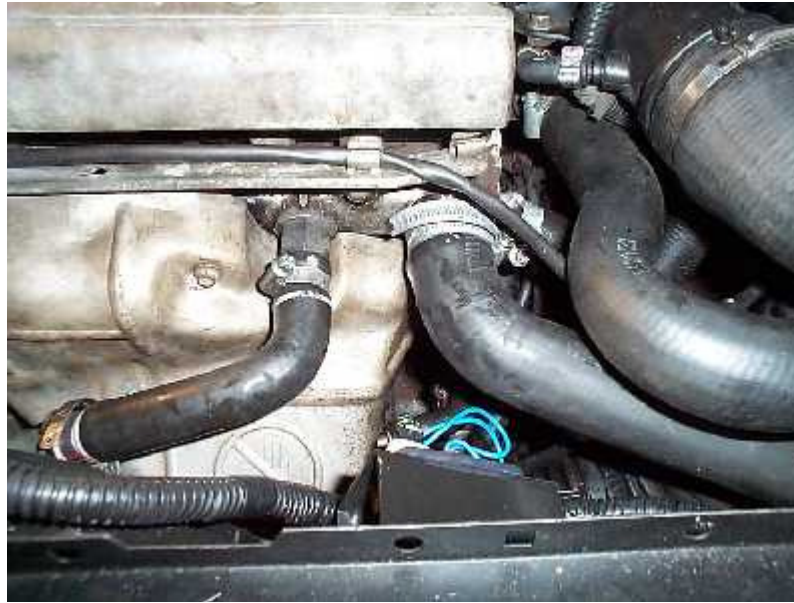
To remove the oil pipes you'll also need to remove the exhaust manifold heat shield as it gets in the way. Remove the coolant hose on the left and drain the system, you can also remove the one on the right to improve access.

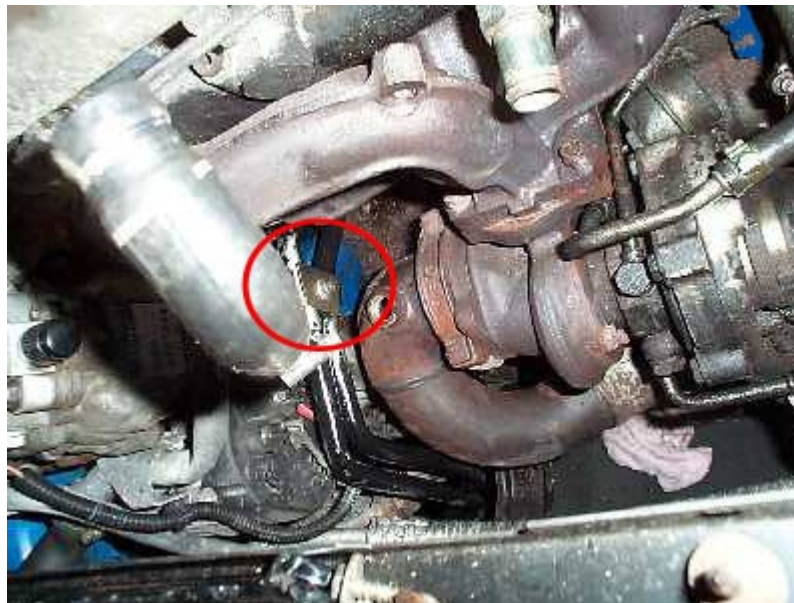
This shows the manifold cover from above with the right hand coolant hose disconnected.

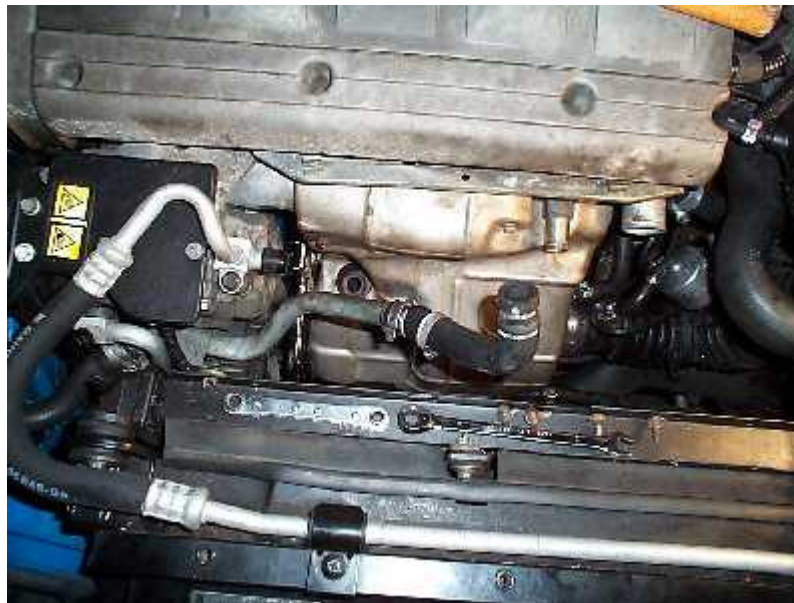
Now, you need to disconnect the second coolant hose and remove the oxygen sensor (lambda probe). To do this you'll need a special 22mm socket which has a cutout in the side for the wiring to pass through. Simply unclip the wiring loom and unscrew the sensor.

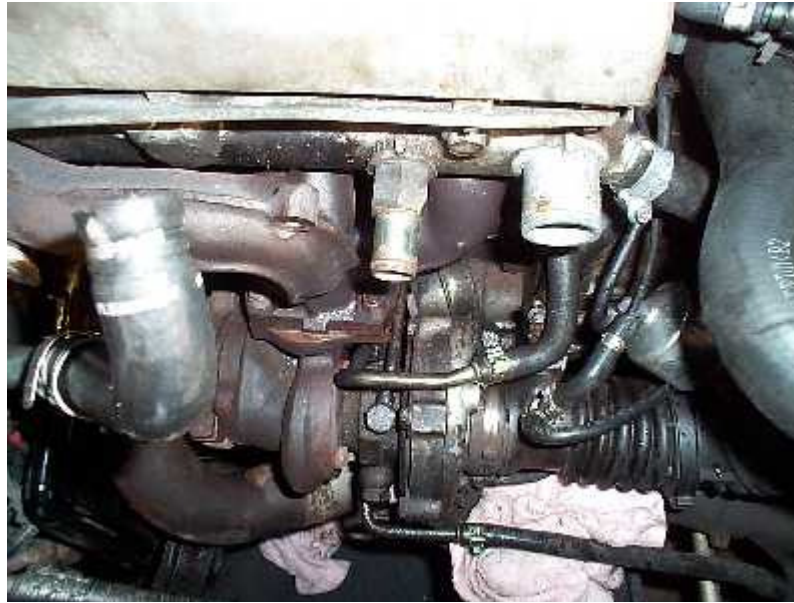
With all that gubbins out of the way simply remove the 2 bolts and one nut holding on the heat shield and take it off.

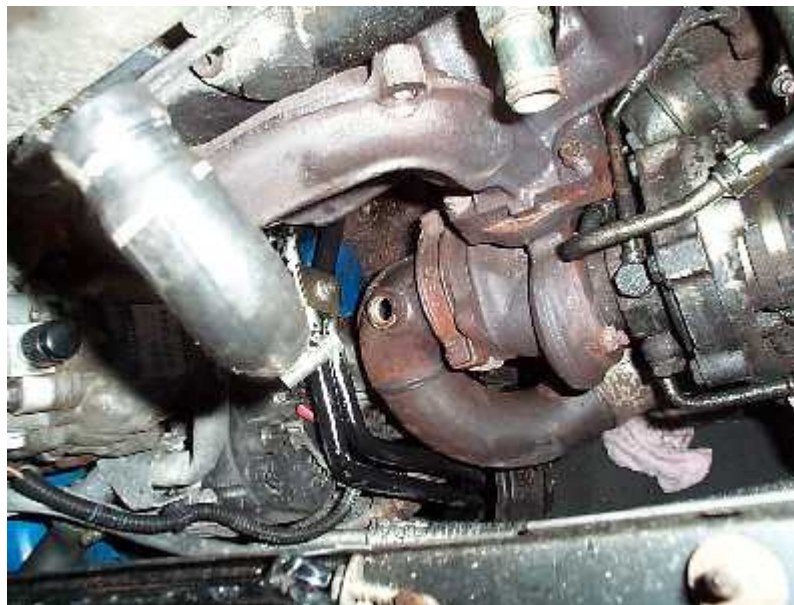
In this photo you can see the oil cooler pipes to the left of the oxygen sensor hole. You can also see a small bracket held on by a 10mm bolt, remove this bolt and bracket first to ease the pipes removal.

The blue item is the oil filter, the oil pipes go in just next to the filter and are held in by 2 10mm nuts which you'll also need to remove (best done from underneath).

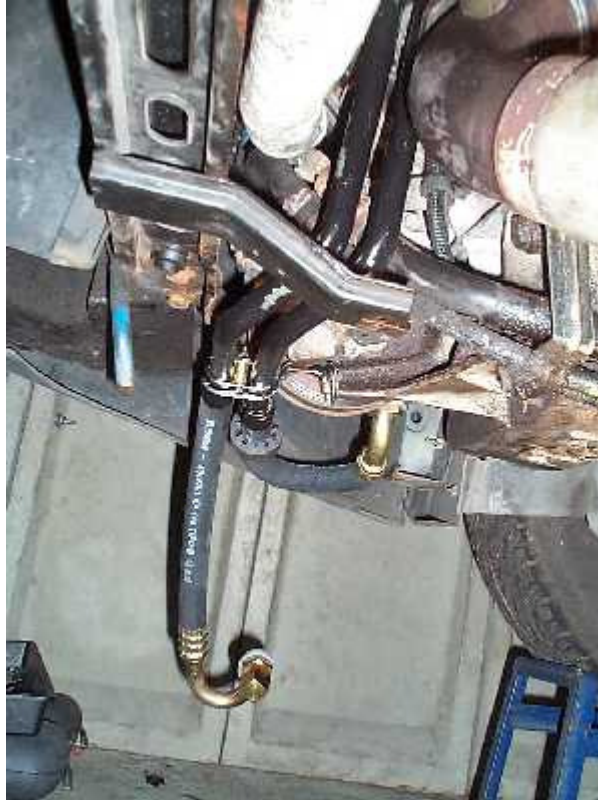
Next, undo the lower support bracket which can be seen in this photo just where the rubber meets the metal pipes. With this support undone, release the oil cooler which is just forward of the drivers wheel and bolted in place with 2 10mm nuts (watch out for the washers and bushes that'll also drop out).

With all this done you'll be able to jiggle the pipes out from engine, it's quite a tight fit but there is just enough room to pull them out.

Once removed you have the unhappy task of separating the pipes from the cooler. As the cooler is made from aluminium and the pipes from steel, they corrode nicely together forming an oil tight and human tight bond!

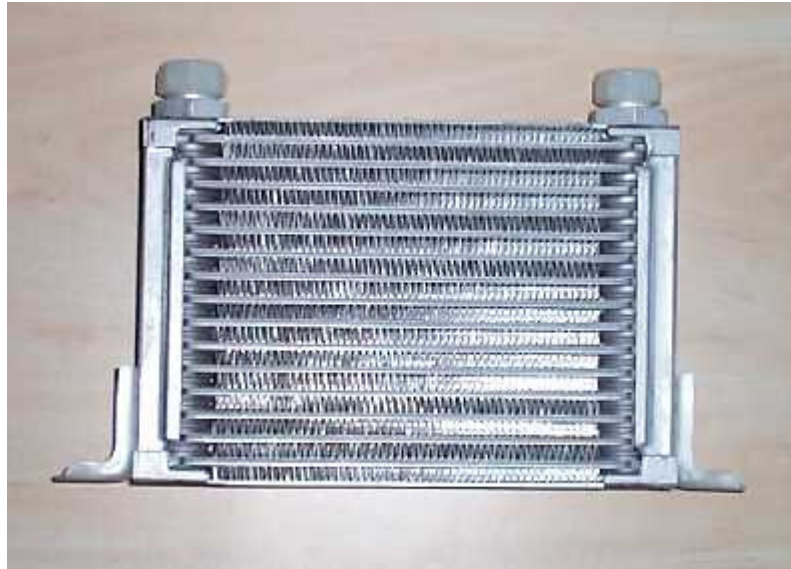
I failed miserably despite the use of releasing oil and a blowtorch, still managed to split the cooler trying to undo the pipes. Above is the new cooler - these are at times impossible to get hold of and I suggest you make sure new ones are available before you get started! It's also worth checking the tightness of the cooler hoses against the cooler after a few weeks.

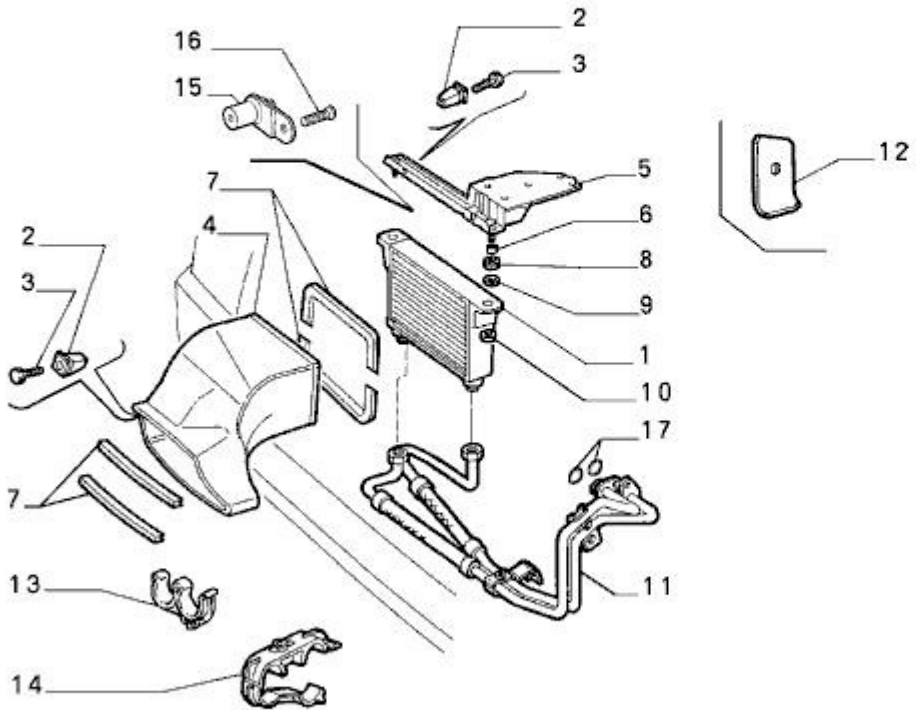
PX / 10309 OIL COOLER - M3

R.	Ord.n°	Description
1	46538495	RADIATOR
2	14203780	PAD
3	15924904	SCREW
4	46303115	CONVEYOR
5	7610183	BRACKET
6	46479979	SPACER
7	46303133	GASKET
8	46479978	RUBBER RING
9	12640601	WASHER
10	12574211	NUT
11	46520897	HOSE
12	46468541	BRACKET
13	7635399	CLIP
14	7673078	CLIP
15	7794411	RUBBER PAD
16	14660290	SCREW
17	7792369	GASKET
